THE EXCAVATION
OF THE
PATTAYA WRECK SITE
AND
SURVEY OF THREE OTHER SITES
THAILAND
1982

Jeremy Green
and
Rosemary Harper

Australian Institute for Maritime Archaeology
Special Publication No.1.
1983

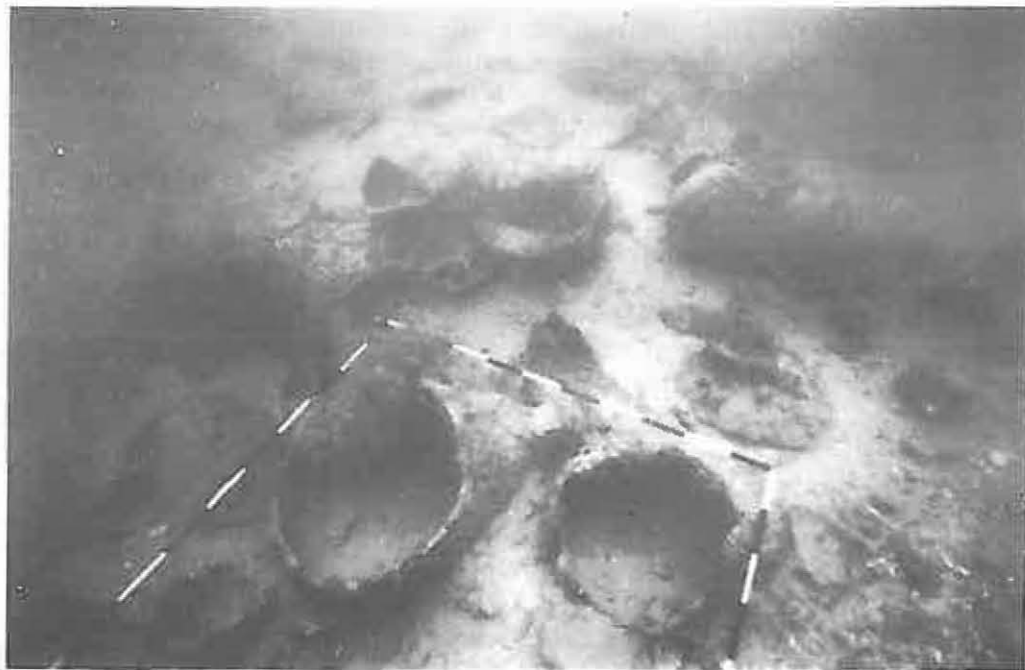
Figure 2. Complete and Semi-complete storage jars on wreck site.

The site lies on a silt-shell seabed at a depth of 26 m. The axis of the site is approximately 30° and the extent of the timber was noted to be about 20 m by 4 m. Around the site were numerous fragments of semi-complete and complete large storage jars (Fig. 2). These had clearly been moved during the previous work on the site, presumably to gain access to deeper layers.

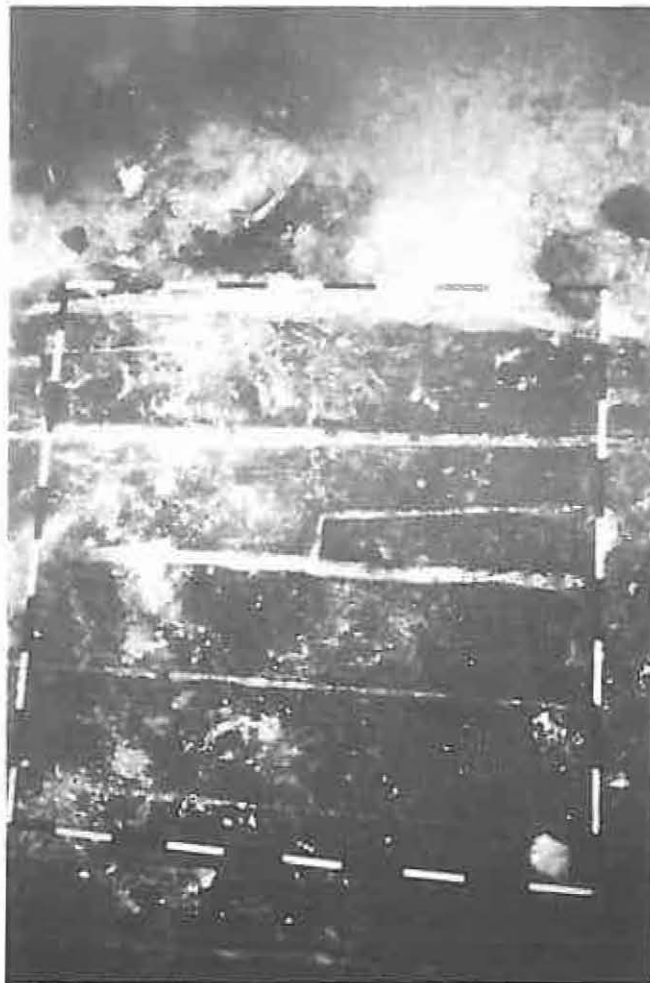
Figure 3. A near vertical photograph of the timbers.

As each section of the hull was uncovered, and during the periods when the underwater visibility was reasonably good, a photomosaic of the site was made.

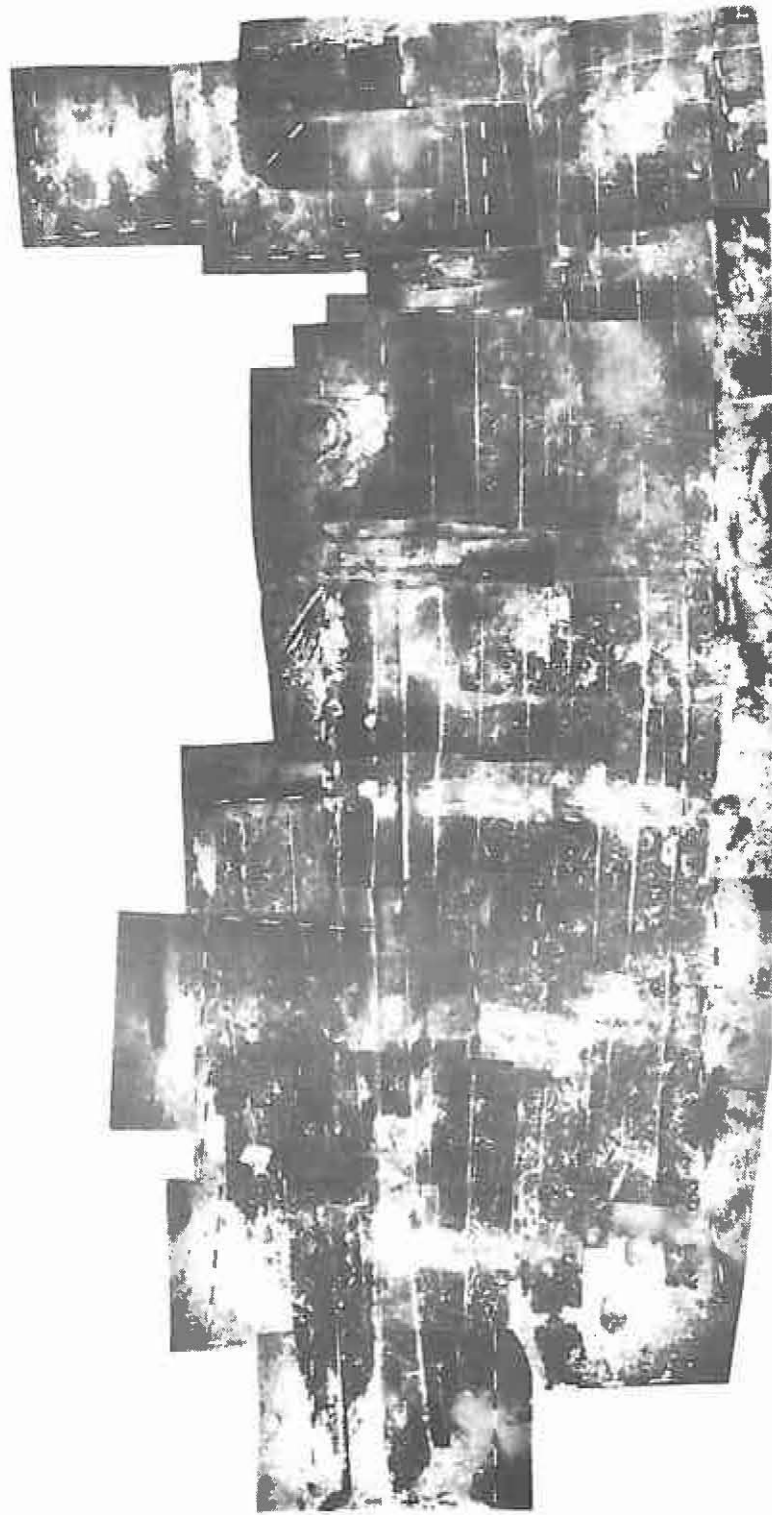
A 1 m square grid frame (graduated in 100 mm intervals) was used in combination with a standard Nikonos Camera and a 15 mm water-corrected lens, to take overlapping photographs over the area concerned. The photographer attempted to position the camera so that it was as near vertical to the grid frame as possible (Fig.3). In general, this coverage was made by a single operator who moved the grid frame over the area and took the photographs. The frame was moved in 500 mm intervals across the site. These approximated to photographic runs, and at the end of each run, the grid was moved forward 500 mm so that, as near as possible, a 100% overlap occurred. The photographs of successive coverages were printed and the results were laid up as a photomosaic (Fig.4). This process has been discussed widely elsewhere, Green *et al.*(1971).

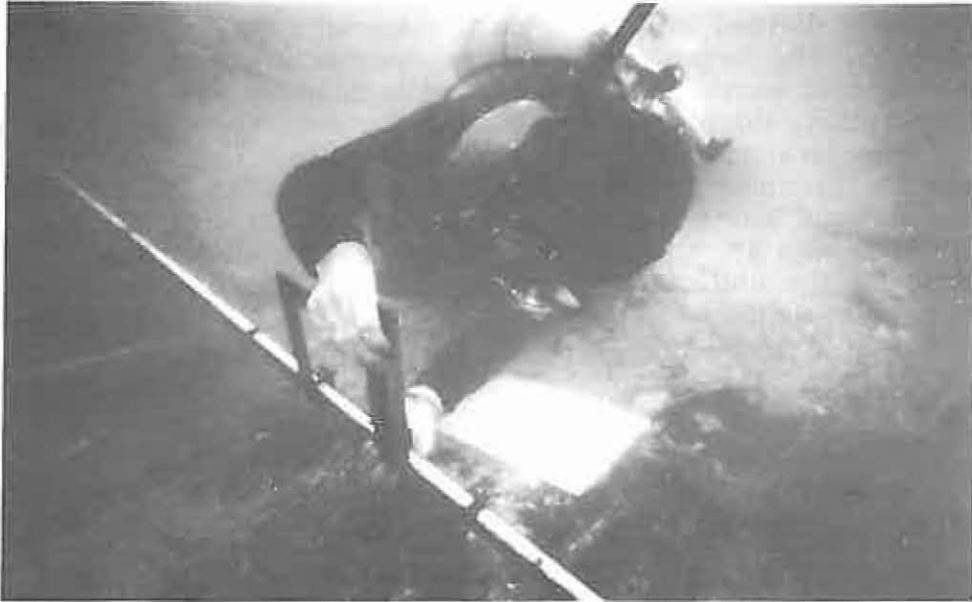
Figure 5. Diver using profile machine.

and its off-set at the bottom measured. By simple trigonometry, the angle of tilt can be determined since the length of the side of the square is known. Thus, in each profile, the angle the bar made to the horizontal was determined.

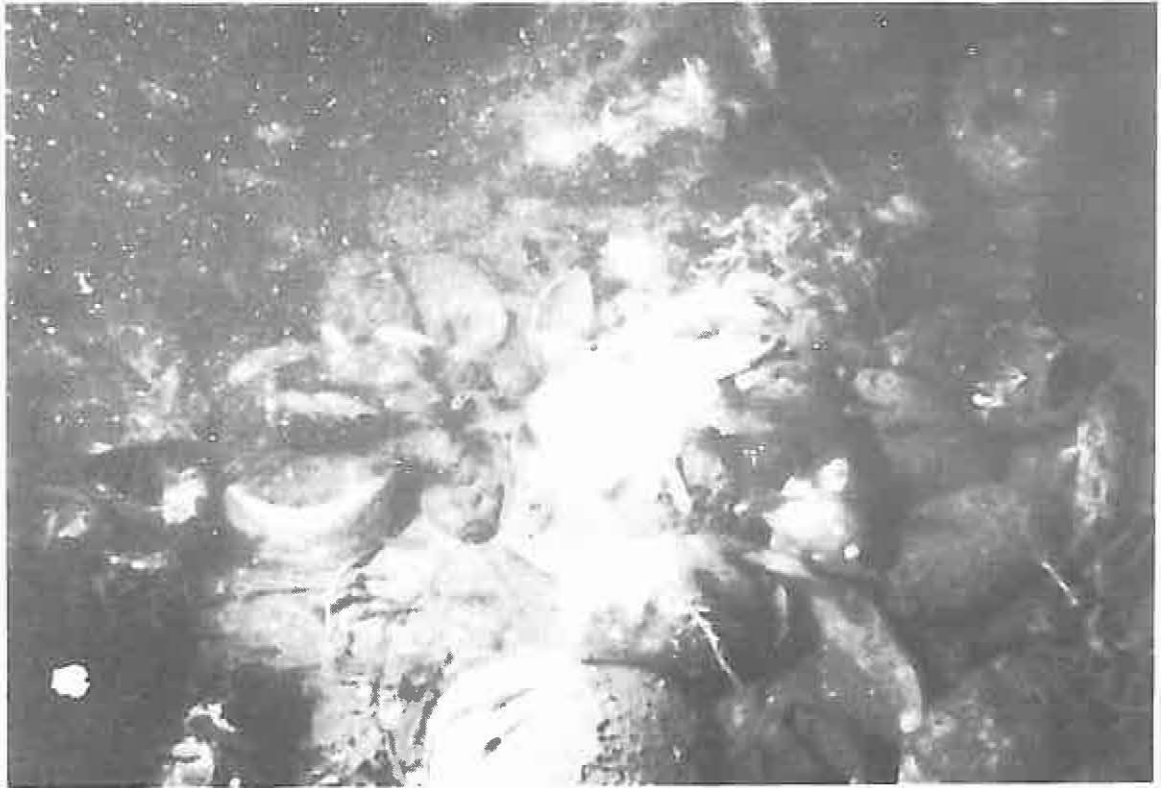
Figure 6. Early photograph of site showing medium jars.

These jars seem to be part of the main cargo of the ship. They are shown prominently in early pictures of the site (Fig.6). The shattered bases of these jars were noted in the concretion area over the keel, between bulkhead 3 and 4 (Fig.7). This type of jar is similar to Spinks (1959) Fig. 51 No.2615 (same height but narrower), said to be possibly Sukhothai. Also Fox (1959) Plate 135 (same height but narrower, as Spinks) said to be Kalong, found at the Calatagan excavation, Philippines. Interestingly, Brown (1975) Fig.8 (left),

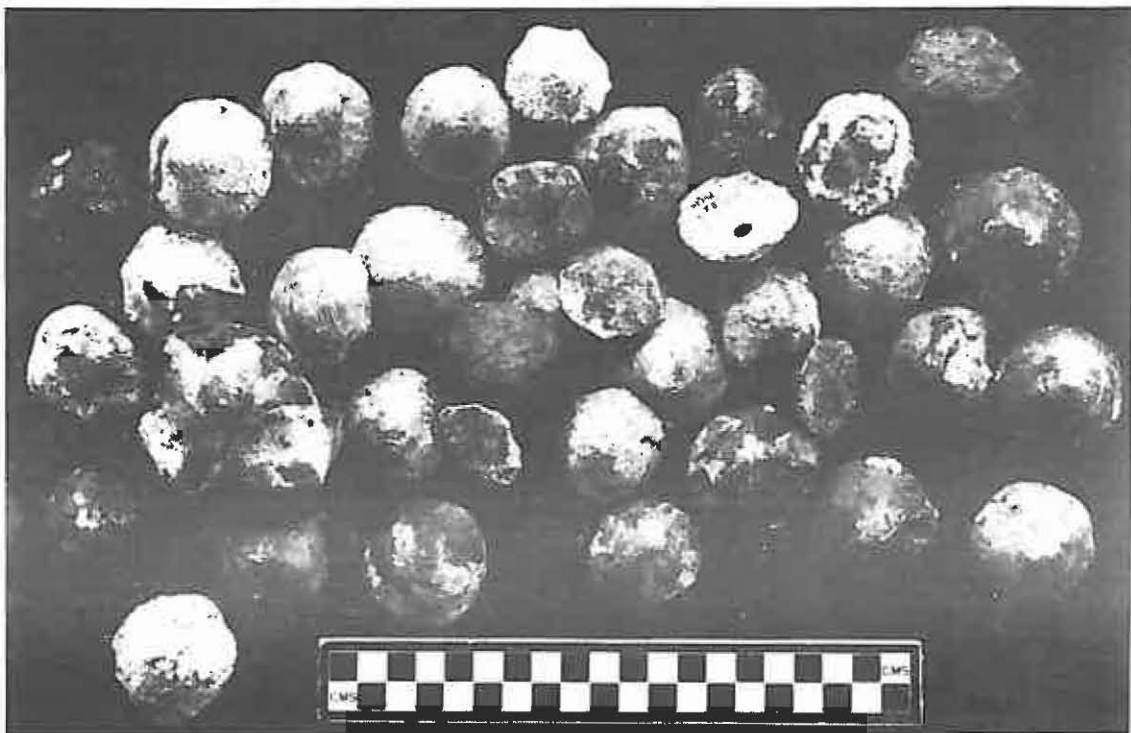
Ingots (262), pyramidal-shaped. Average approximately 20 mm high, 42 mm wide. Maximum 24 mm high, 47 mm wide.

A number of these lead ingots were found on the site. They have been previously described by Howitz (1977) Fig. 20 and Howitz (1978) Fig. 33. Howitz reported that many tonnes were salvaged from this site by treasure-hunters and that they were a common find on wreck sites in Thailand. Interestingly, similar lead ingots were found on Site G, (see below).

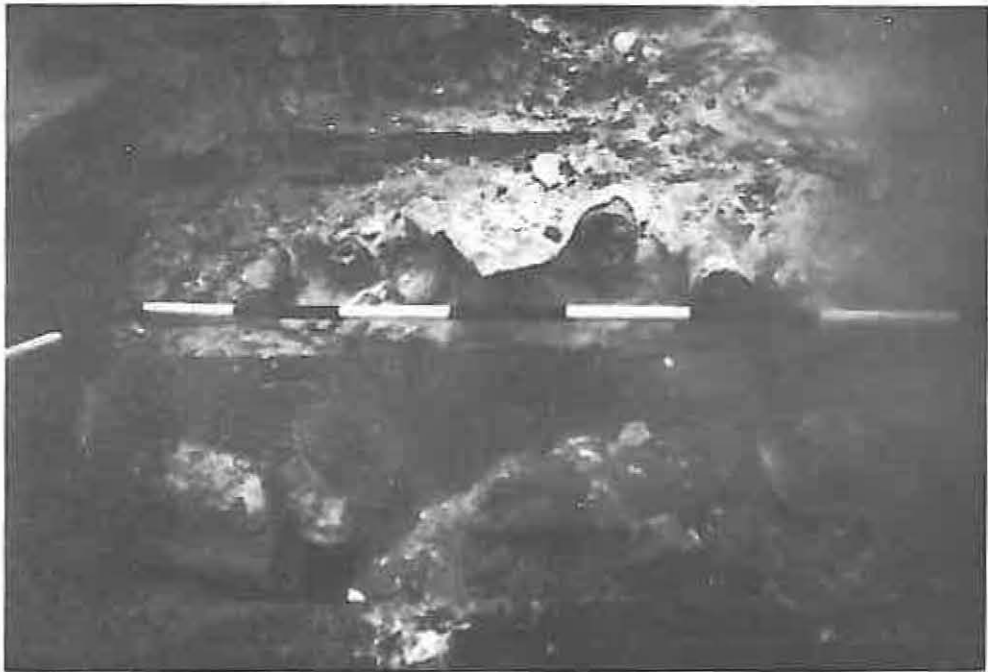
Figure 8. Bamboo dunnage lying across the keel.

concretion were some medium-sized jars (see Section 3b above). Also, a number of bamboo poles had been layed across the keel. These extended into the western side of the site, under the concretion (Fig.8). Interestingly, the interior of these bamboo poles were crystals which when analysed, were found to be calcite. See Appendix 1.

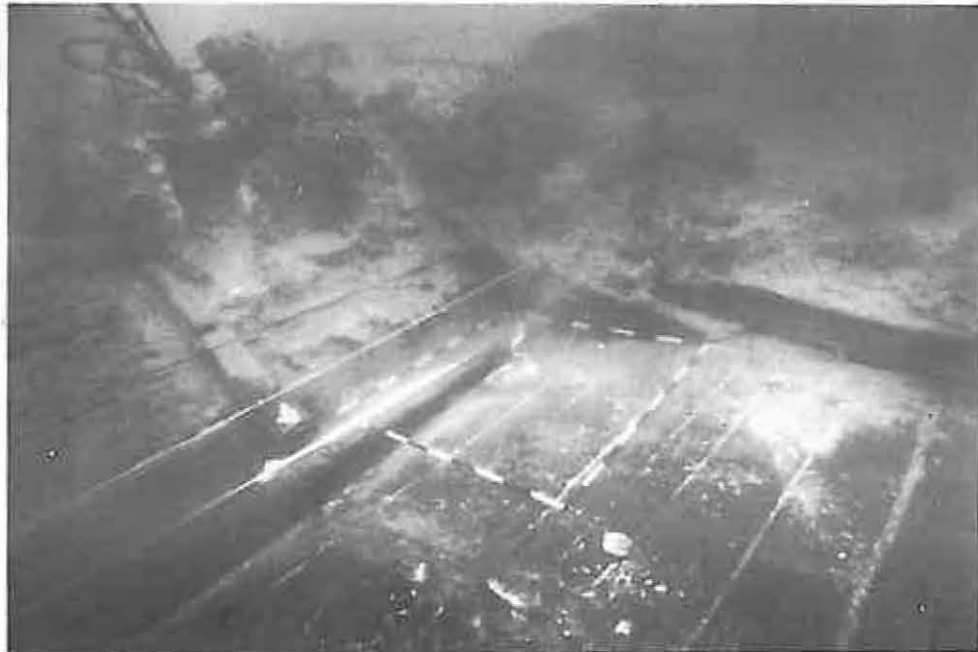
Figure 9. Pattaya wreck showing hull profile.

In all, a 9 m length of the hull was uncovered, with a maximum width of 4.5 m. In this section, six bulkheads were uncovered together with eight strakes on either side of the keel. The hull profile had a marked V-shape next to the keel. This flattened out, finishing in an upward curve at the turn of the bilge. Here, obviously, the continuing sides of the ship had broken away and disintegrated (Fig.9).

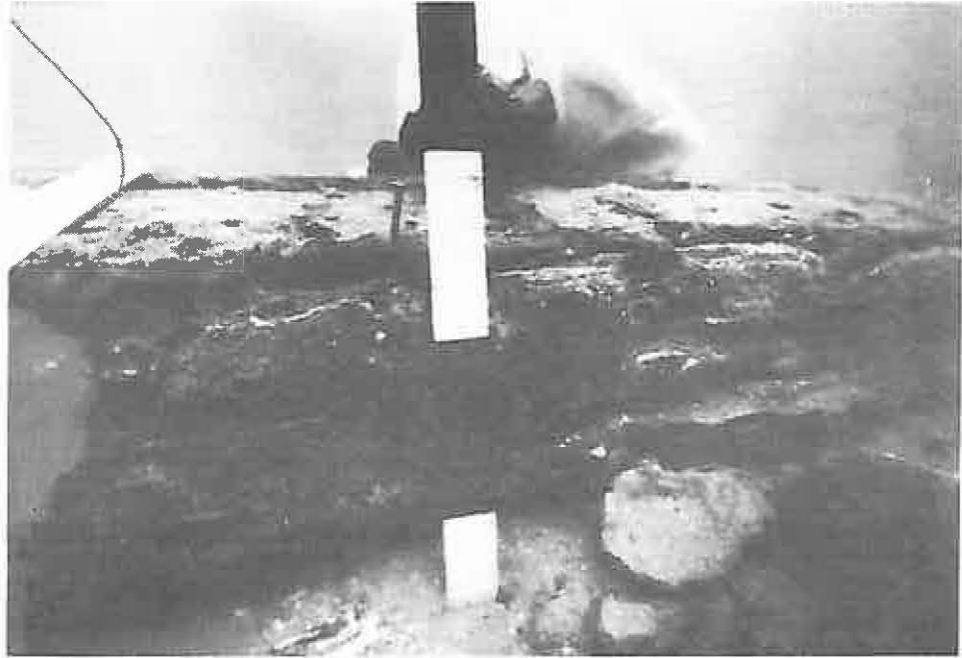
Figuer 10A. Planking at edge of site showing layers.

checked into the keel. It is thought that the second strake which now becomes the garboard, is treated in the same way, the checking however occurring outside the surviving timber area.

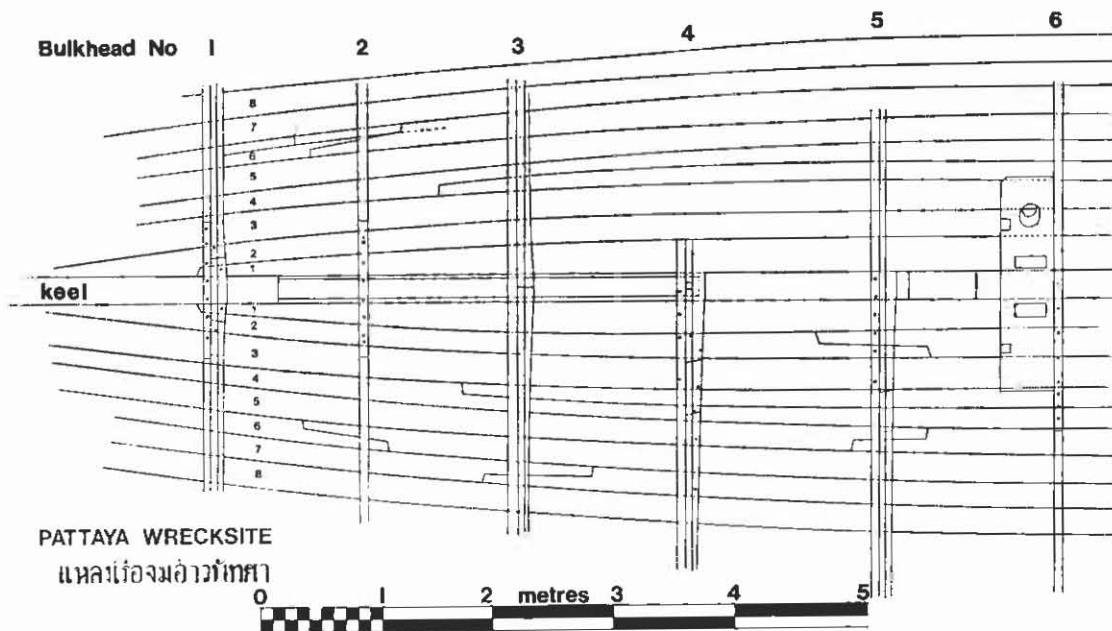
Figure 11B. Pattaya wreck site plan.

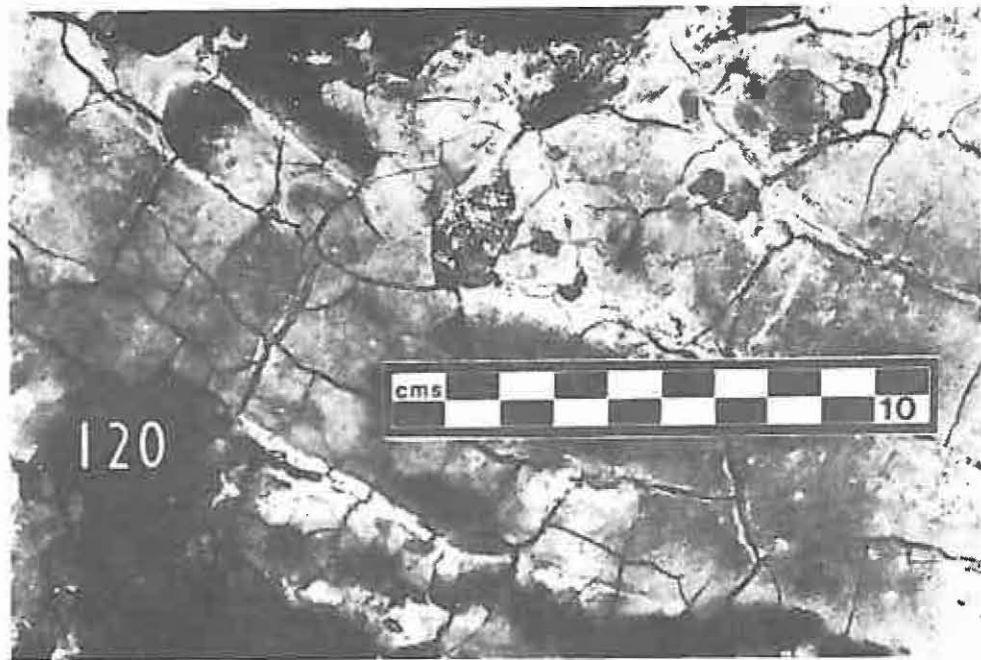
Figure 12. Luting on outside surface of inner plank fragment.

The two outer layers of planking seem to be butt-jointed rather than scarphed. A small section of the second layer of planking was revealed where a part of strake 6 on the west side of the site was missing. Here, a flush-faced butt joint was revealed. It is interesting that there was no evidence for dowel edge-joining. It is assumed that this planking is nailed onto the inner planking as a type of skin. Some evidence that nails were driven from the outside into the inner planking, was noted. Resin-lime luting was noted on the outside surface of an inner plank fragment (Fig.12).

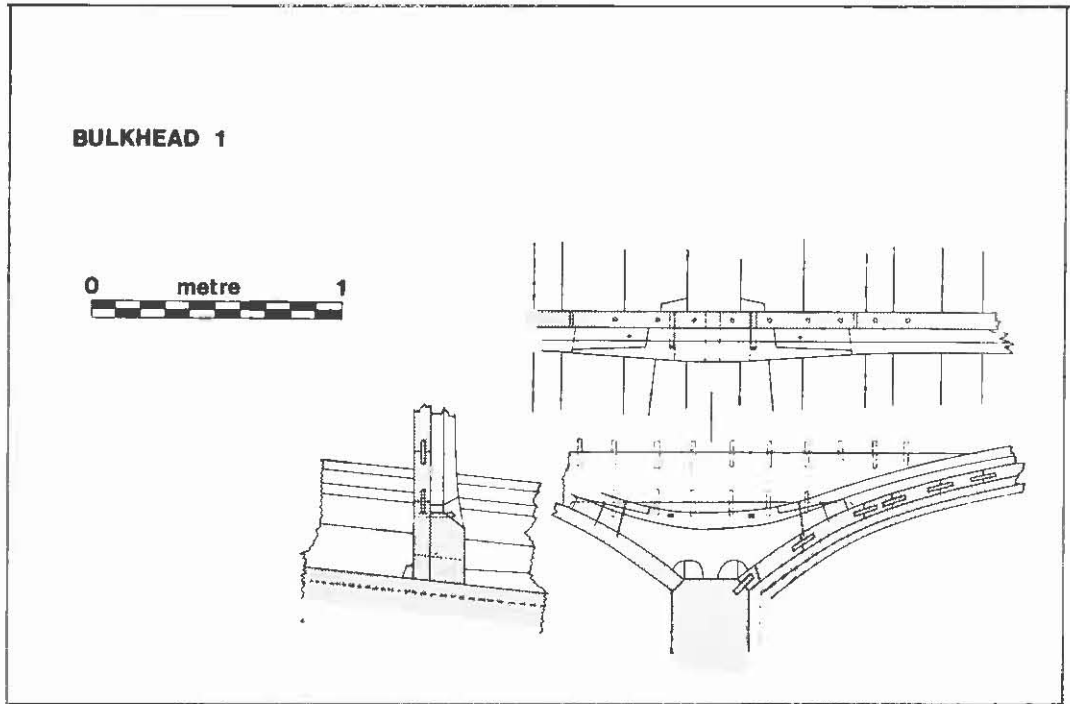
Figure 13A. Bulkhead 1.

Traces of six bulkheads were found on the site. Remains of dislodged sections of bulkheads were found lying around the wreck site enabling a reconstruction of bulkheads 1 and 2 (Fig.13).

The construction of the bulkhead was as follows, the bulkhead consisted of a number of parallel planks 70 mm thick, dowelled together with round pegs in the same manner as the strakes of the hull planking. The ends of the planks were shaped so that they fitted flush with the hull planking, and appeared to be lightly nailed to the planking at the narrow ends. There was no evidence of dowels being used to join the bulkheads to the hull. The lowest bulkhead plank is triangular in section, lying symmetrically over the keel. The extreme ends of the planks were also trimmed in the same way as the scarp-joint of the planks.

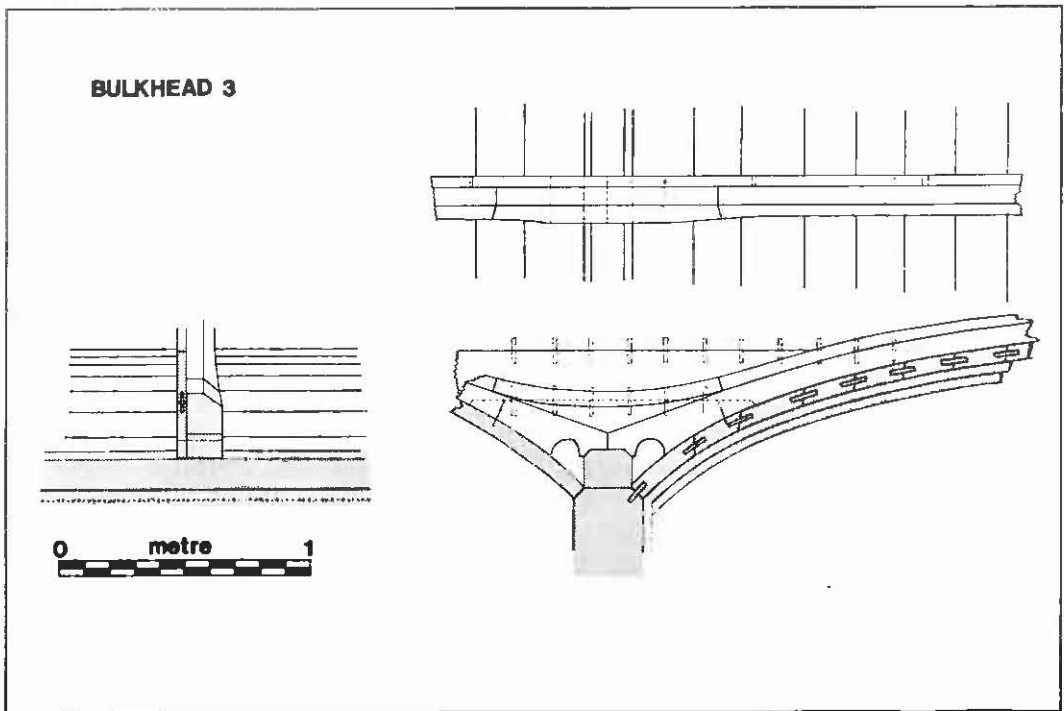
Figure 13B. Bulkhead 3.

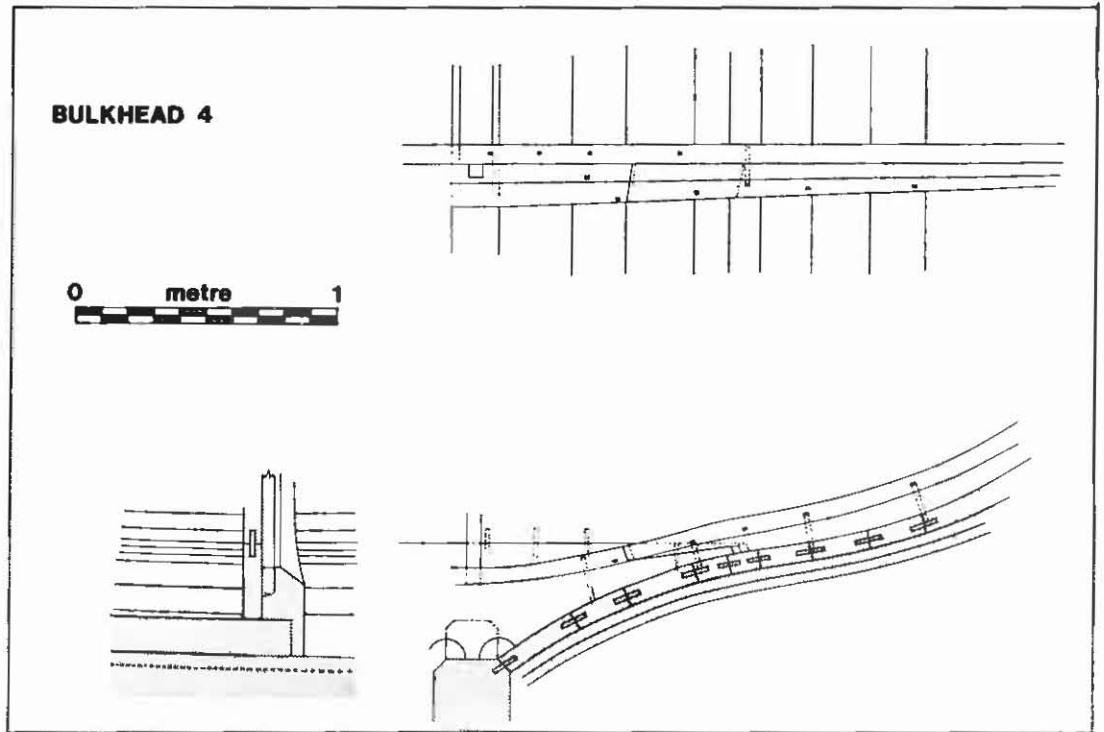
Figure 13C. Bulkhead 4.

Because of the additional keel member on top of the keel, the shape of bulkheads 1 and 5 were different from bulkheads 2, 3 and 4.

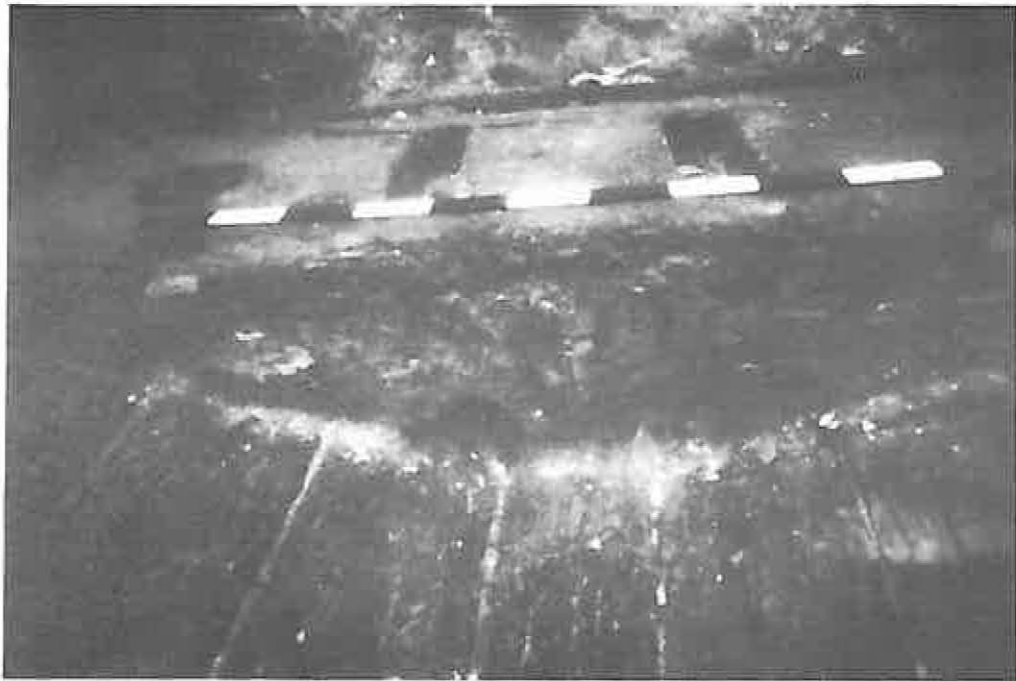
Figure 14. The mast step.

stepped layers of strakes; thus a series of strakes is broken by a step, so that some strakes resemble carvel construction and some clinker. Furthermore the planks are joined in a narrow rebate (Song Shipwreck, 1975d Fig. 3 (top), between pp. 30 & 31). The lower part of this figure shows the mast step. The mast step clarifies a number of problems in interpretation of the Pattaya shipwreck. On the Pattaya site, it was initially far from clear which was the bow and which was stern, and the discovery of the mast step did not resolve this; it was tentatively thought that the bows were to the north, because the mast step sockets gave the greatest strength to the south. The Quanzhou ship mast step shows that the step is braced against the bulkhead on the aft side. Thus, the leverage on the mast caused by the sails is exerted forward at deck level and aft on the step. Thus, the step is located against the bulkhead, with two longitudinal, square-section wooden braces or chocks running between the step and the next bulkhead forward. This explains the two small notches on the leading edge of the step; these are almost certainly to locate these braces.

A similar mast step has been found on the Bukit Jakas site at Pulau Bintan in the Riau Archipelago, Indonesia (see Manguin's report in Appendix 2). The mast step, in this case, seems to be at the stern, with the step on the side of the bulkhead away from midships. This step also has similar notches, but these are orientated away from midships. The frames in the bow section of the site are on the midships side of the bulkhead, indicating that this arrangement changes somewhere in the centre of the site (as yet unexcavated).

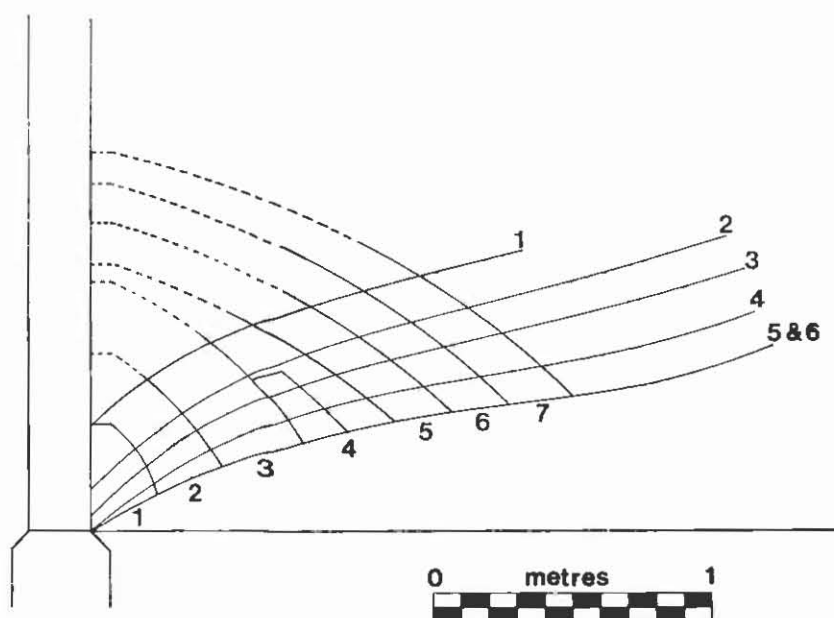
Figure 15A. Body plan showing strake lines.

The lines drawing of the hull (Fig.15), is an attempt to project what the missing hull structure looked like. Unfortunately, only a small portion survived, and the recording was insufficient to make an adequate reconstruction. In view of the fact that the stern section is still to be excavated, these plans should be considered tentative.

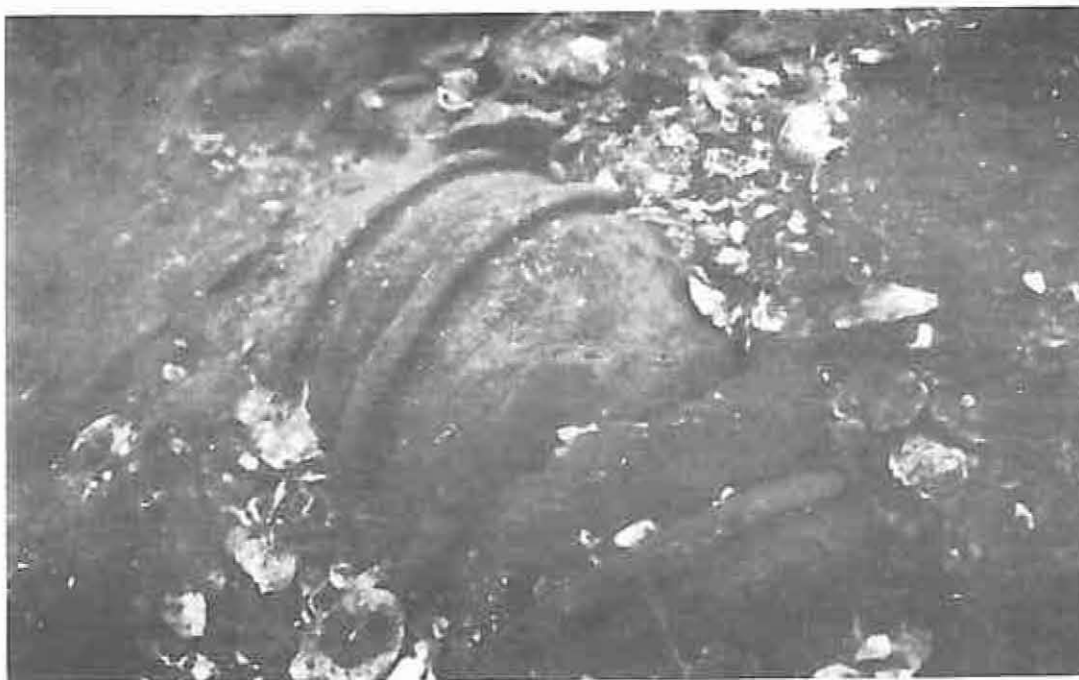
Figure 16. Wreck site G, basins stacked in a row.

basins or bowls (G43) were found as part of a series, stacked together and lying on their sides (Fig.16). The kendis were found in a group, some on the surface (Fig.17), and the blue and white porcelain was located by one diver. Large structural timbers were also noted and photographed on the seabed.

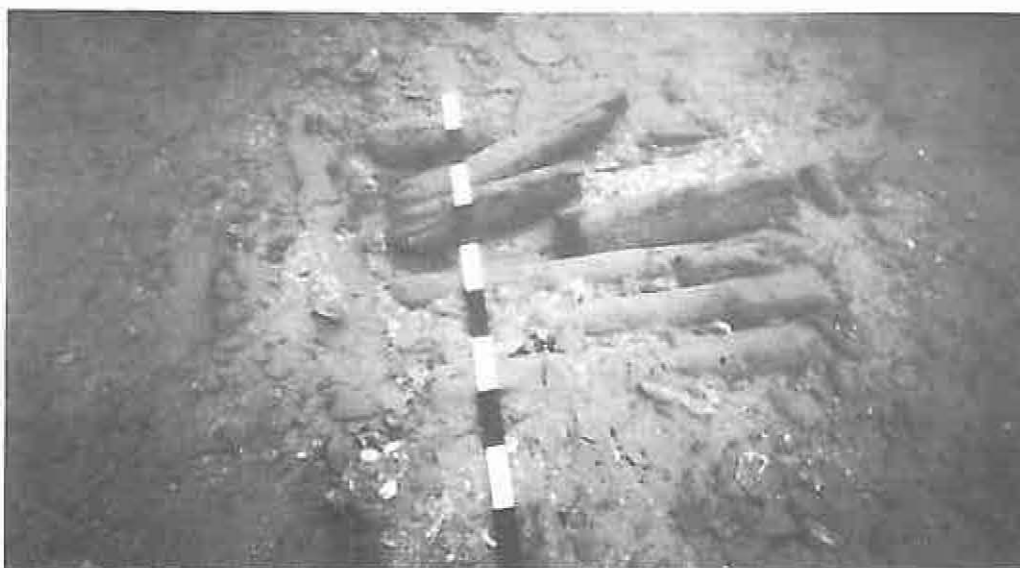
Figure 18. Unshaped timbers butting against longitudinal timbers.

This is an extraordinary find, since one would expect, particularly in such warm water, that exposed timber would be completely eaten away by toredo worm and marine organisms. Two timber areas were noted. One small area, about 1 m x 1 m, where seven round, unshaped timbers, about 100 mm wide were found lying side by side, butting against some longitudinal timbers (Fig.18). In the other area, square shaped timbers, about 200 mm wide and 200 to 400 mm apart, were noted extending over an area about 2 m square (Fig.19). There is no doubt that this represents some form of integral hull structure, but from such a superficial survey it is not possible to draw any positive conclusions as to what part it represented on the ship.

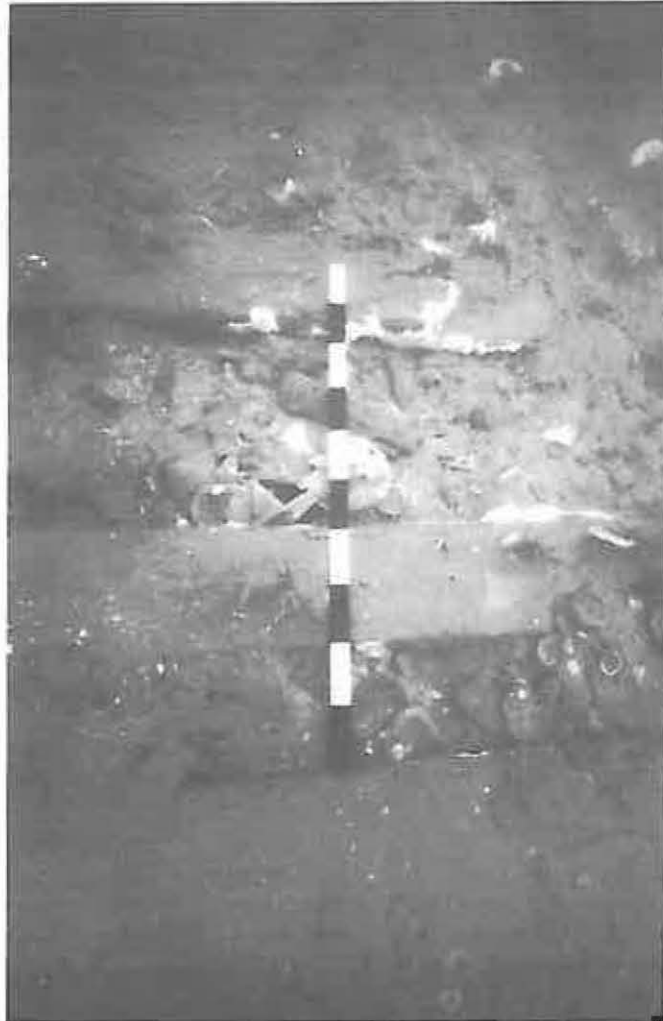
Figure 19. Wreck site G, square shaped timbers.

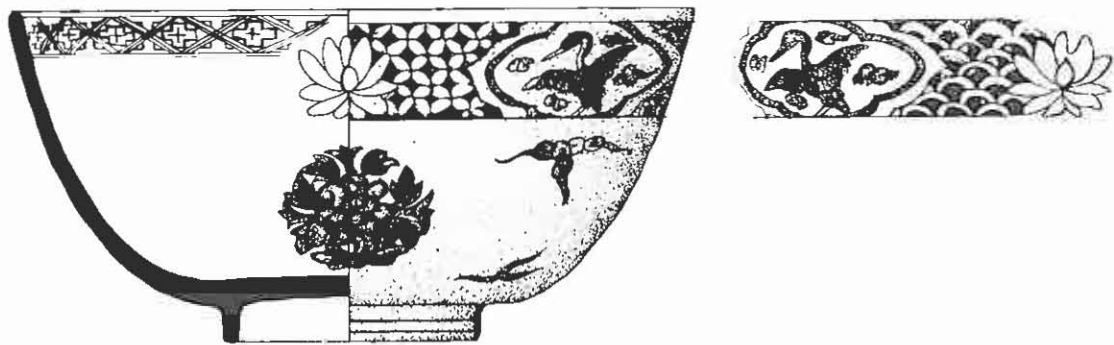
G1
Blue and white. Central medallion has scene with three geese. Diaper decoration on rim of cavetto. Exterior outer rim - open lotus, alternating with fish scale and floral diaper. Four cranes in flight and cloud scrolls within a four-sided, scalloped medallion. Below are floral medallions and cloud scrolls. Chinese inscription under base reads "Da Ming Wanli Nian Zhi" (Made in the Great Ming Year Wanli). Wanli reigned from 1573-1620.

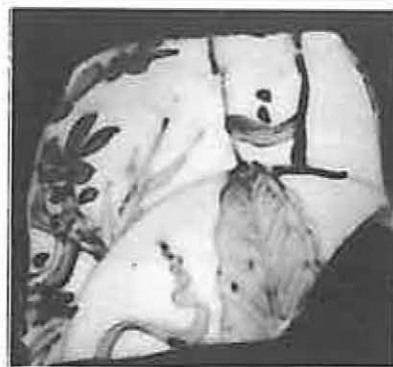
G7/8

Eggshell thin body with vertical ribbing. Blue and white decoration - furniture, possibly an altar on outside and vegetal inside. Glazed on base.

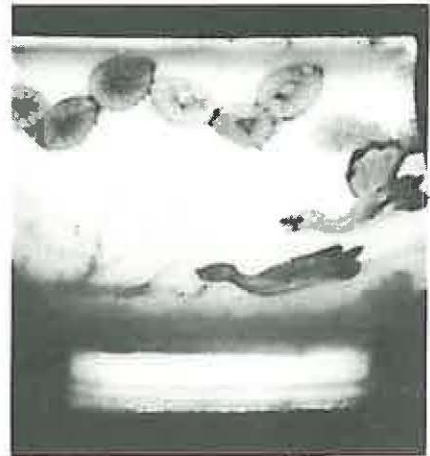
G6
Eggshell thin body, blue and white. Decoration - geese swimming, possibly underwater, and lotus leaves. Interior medallion with foliage. Glazed on base.

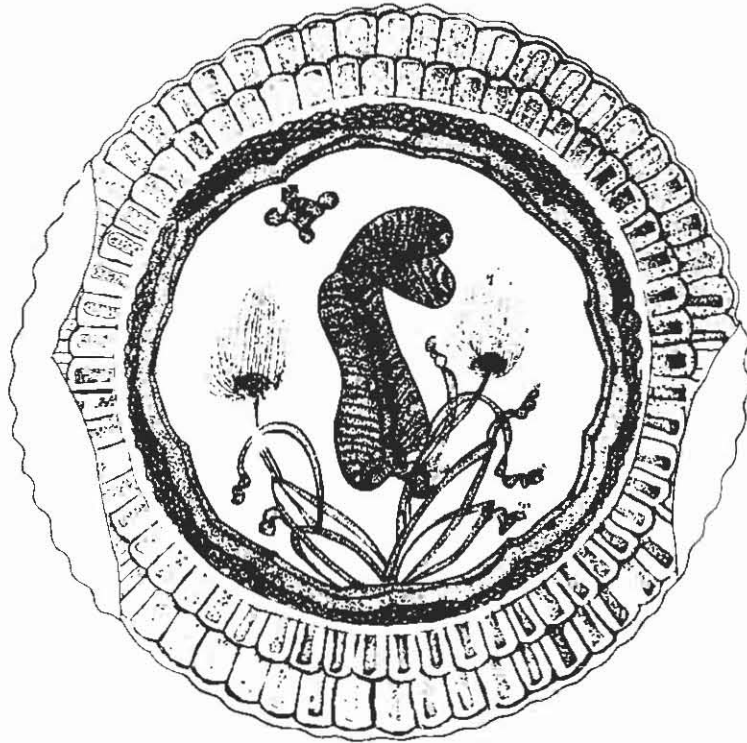
G3
One of a pair. Body vertically ribbed. Blue and white.
Decorated with a fan, which is the Daoist emblem
attributed to Zhong Li Zhuan representing the military
soldier. Glazed on base.

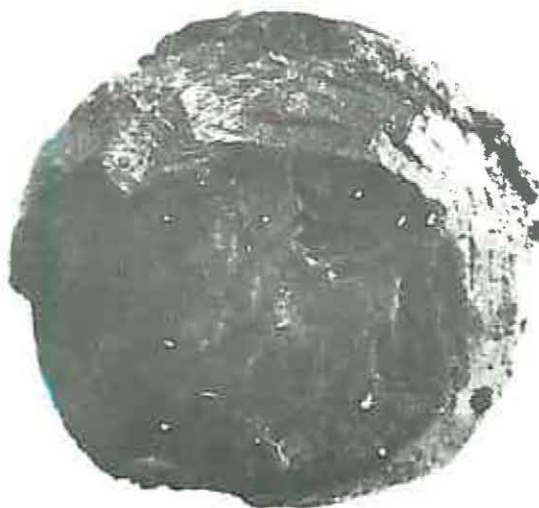
G51
Wooden bung, roughly carved. Resin on the rim of largest diameter. From G50.

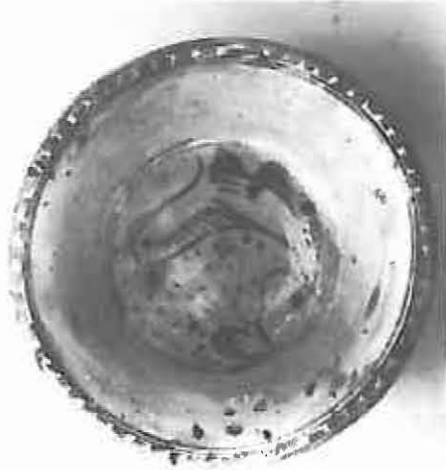
R1 1:4
Bowl, flared rim, carved footrim. Coarse pink-red body with sand particles 1 to 1.5 mm in diameter. Degraded glaze. Brush decoration on lip, three line decoration outside. Five spur marks inside.

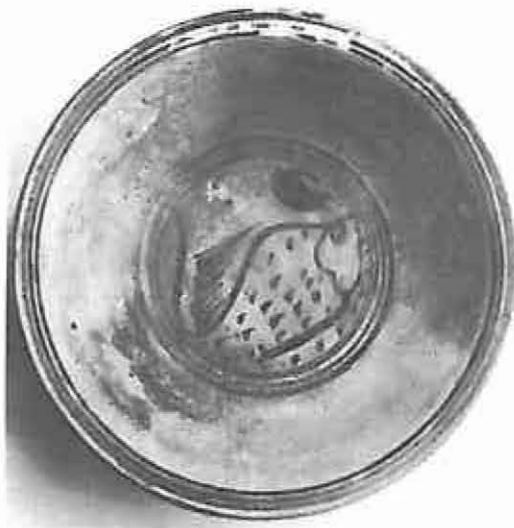
R5 1:4
Shallow bowl, flattened rim, carved footrim. Pink-red body much finer than R1, R2. Degraded glaze, three lines on rim, three lines outside. Five spur marks inside.

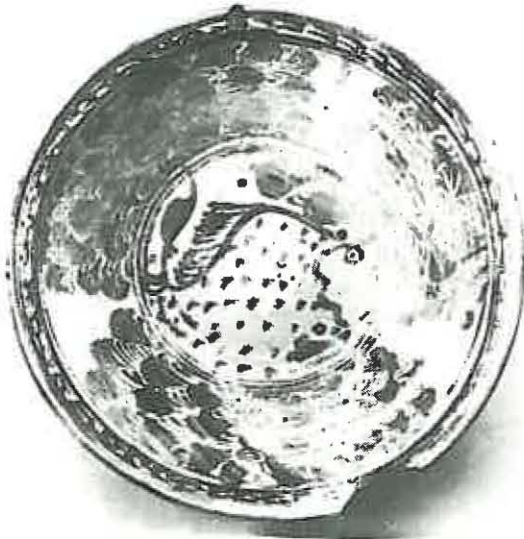
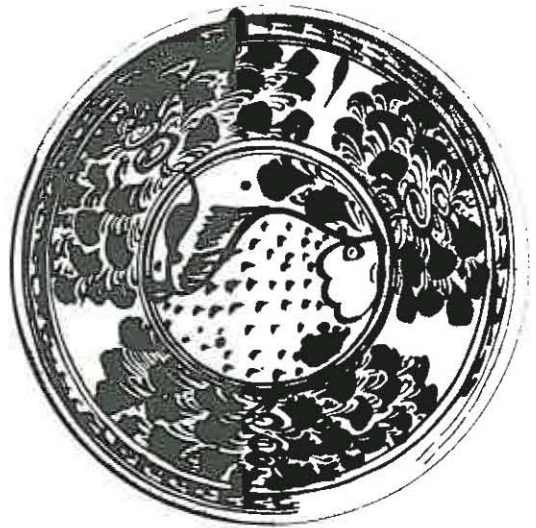
R3
Shallow bowl, flattened rim,
carved footrim. Grey body.
Degraded light green-white
glaze. Brush chevron
decoration on rim, line
decoration outside. Five spur
marks inside, tubular pontil
mark on base.

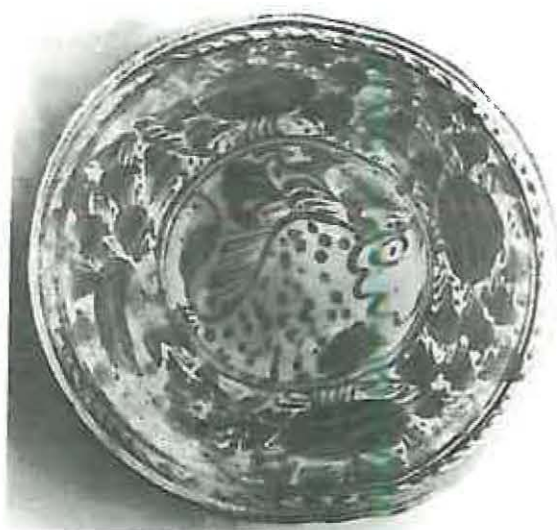
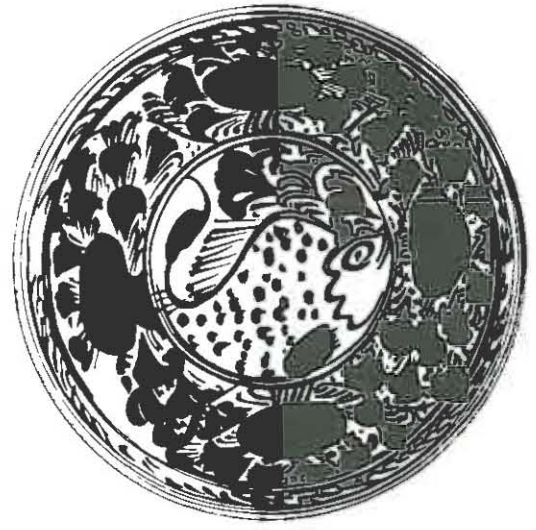
R4
Shallow bowl, flattened rim, carved footrim, floral
decoration vegetal scroll. Pink-beige body. Degraded, light
green-white glaze. Five spur marks inside. References: Brown
(1977) No.91, Howitz (1978) Fig.12, Refuge (1976) Afb.15,
Spinks (1959) Fig.10, No.443, Willetts (1971) No.162.

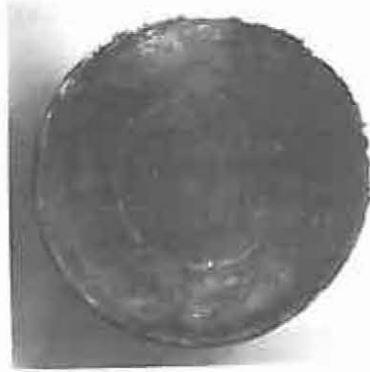
R7 1:4
Bowl with carved footrim. Light pink-grey body. Thick green-blue glaze, possibly celadon. Crawling occurs, forming an unglazed, incomplete circle where inside base joins cavetto. Underpainted but pattern indistinct. Lightly crazed. Tubular pontil mark on base.

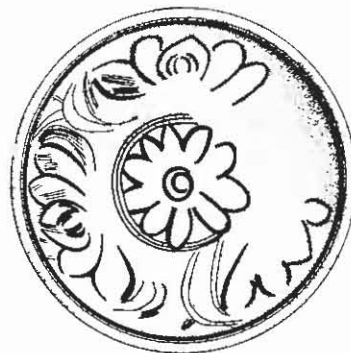
R8 1:4
Bowl with carved footrim. White-pink body. Degraded green glaze. Incised decoration, flower medallion interior, three open lotus and three lines on cavetto. Thick, incised vertical lines outside. Tubular pontil mark on base.

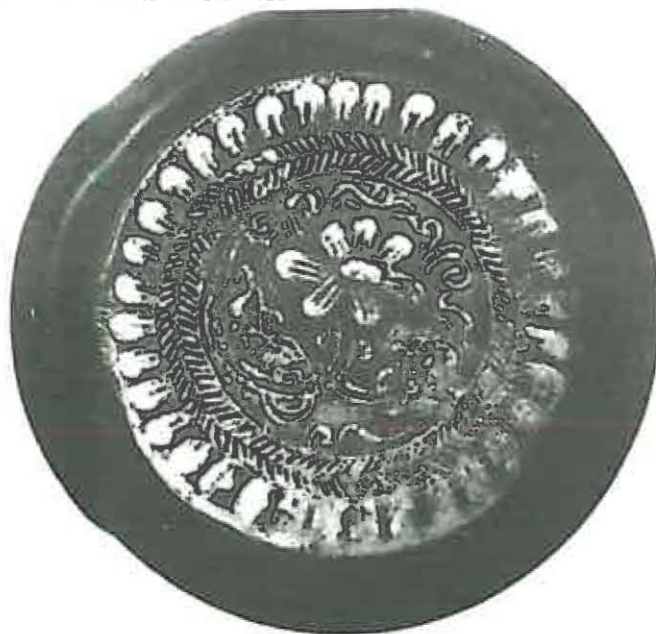
1:1
 Thick light buff body. Smooth brown glaze surrounds moulded decoration. Thin layer of glaze over decoration. Press-moulded, finger impressions inside.
 References: Loesin (1967) No. 152, Oriental Ceramic Society (Hong Kong) (1979) No.29.

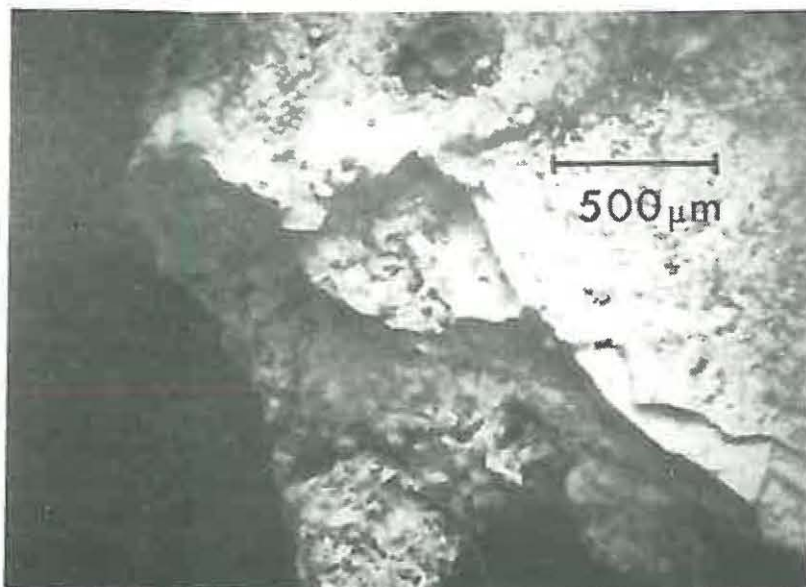
Figure 20A. Overall view of the corroded metal.

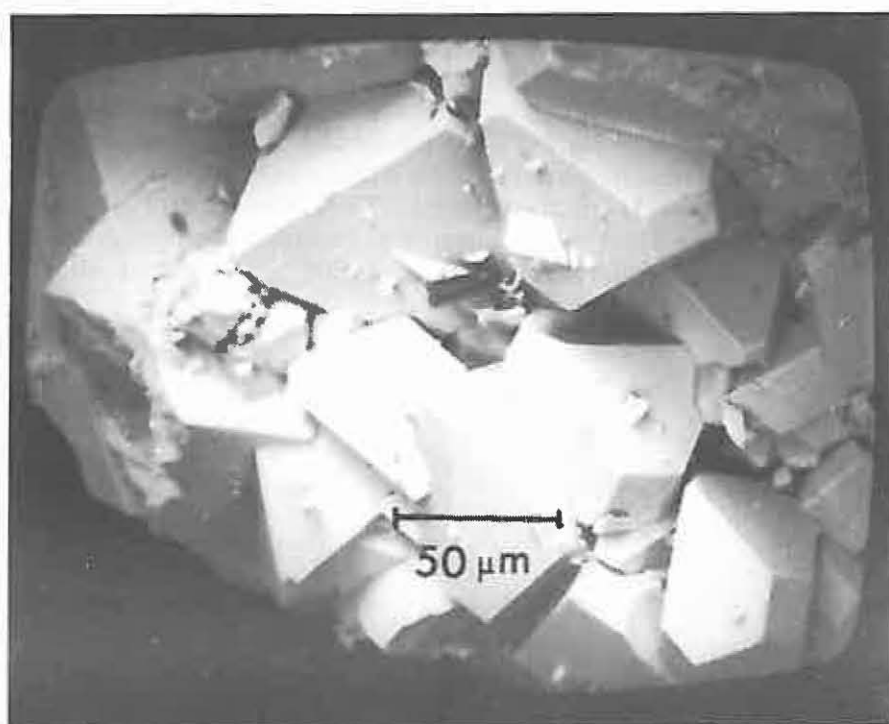
Figure 20B. More detailed view of the crystalline growths.

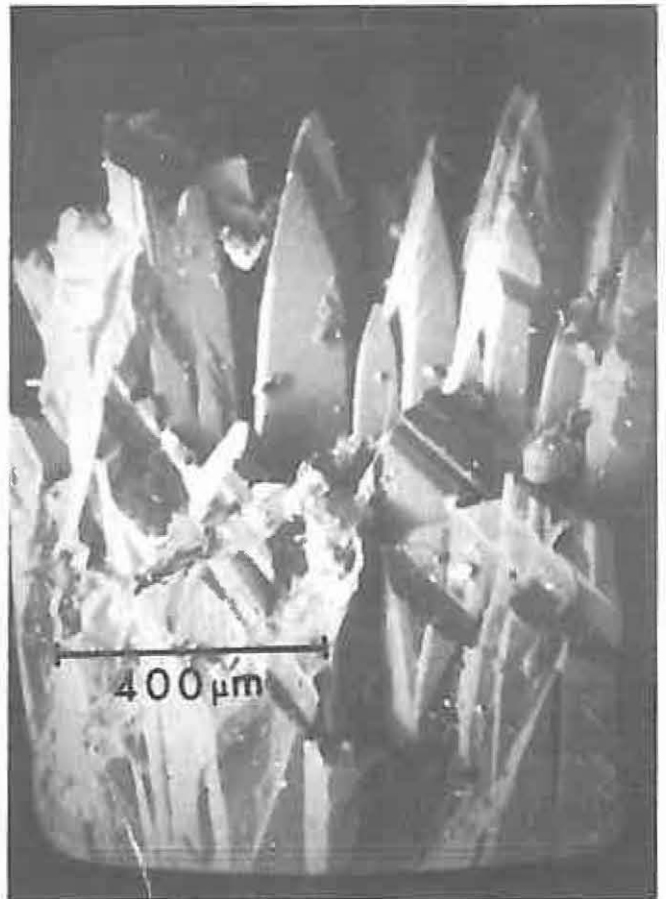
Figure 20C. S.E.M. micrograph showing the crystal habit of calcite.
