THE EXCAVATION
OF THE
PATTAYA WRECK SITE
AND
SURVEY OF THREE OTHER SITES
THAILAND
1982

Jeremy Green
and
Rosemary Harper

Australian Institute for Maritime Archaeology
Special Publication No.1.
1983

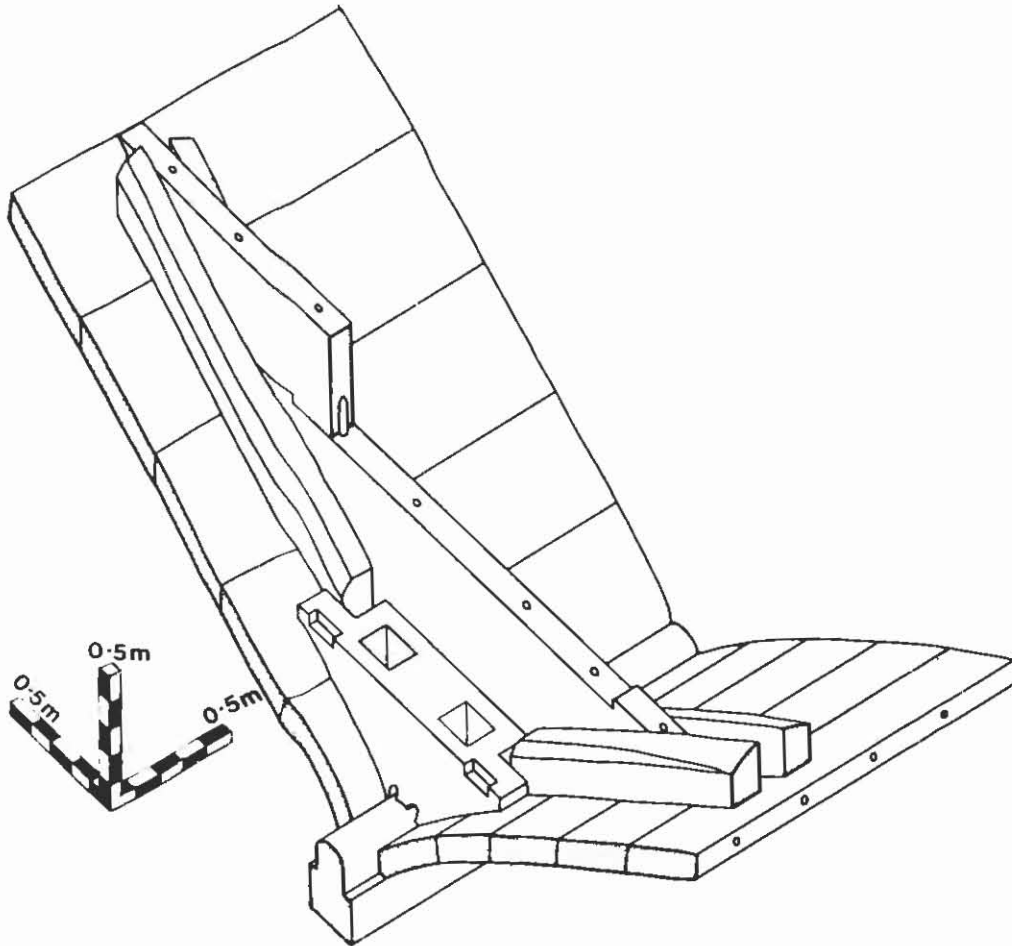
Figure 21. Reconstruction of bulkhead No.16 and mast step, axonometrical view.

A similar mast step has been found on the Bukit Jakas site at Pulau Bintan in the Riau Archipelago, Indonesia (see Manguin's report in Appendix 2). The mast step, in this case, seems to be at the stern, with the step on the side of the bulkhead away from midships. This step also has similar notches, but these are orientated away from midships. The frames in the bow section of the site are on the midships side of the bulkhead, indicating that this arrangement changes somewhere in the centre of the site (as yet unexcavated).
