**THE GRIFFON COVE WRECK:**  
a case study in archaeological reconstruction  
of timber hull remains.

Australian Institute for Maritime Archaeology  
Special Publication No. 2.

# THE GRIFFON COVE WRECK

a case study in archaeological reconstruction  
of timber hull remains

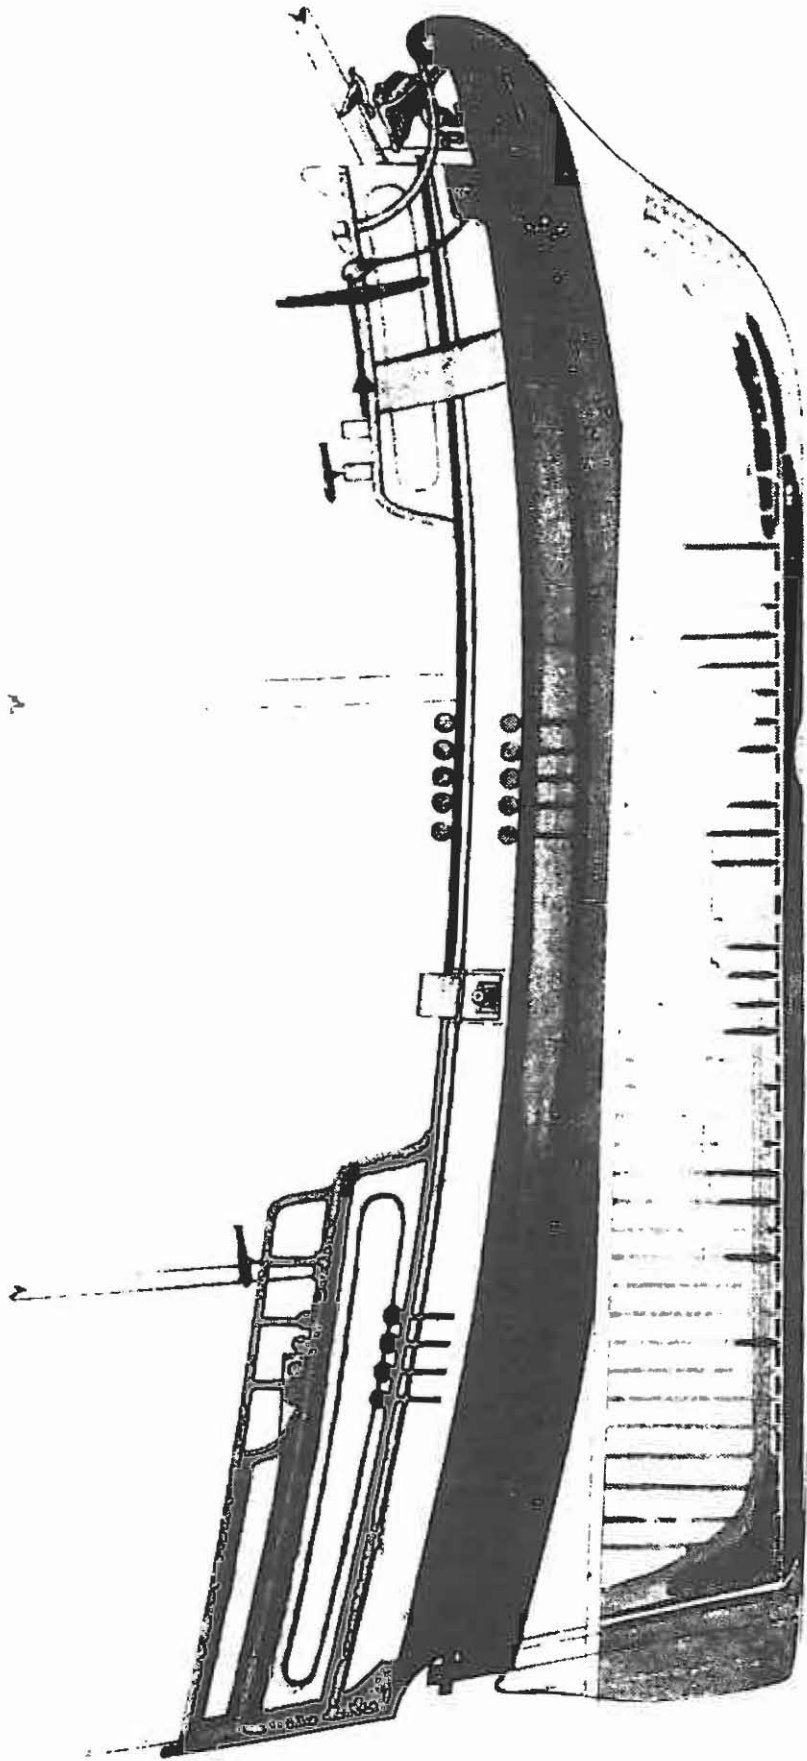
Figure 4. Reconstruction of the 'Griffon' by Murphy

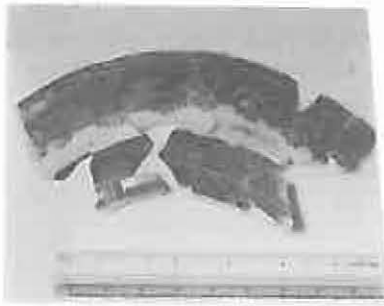
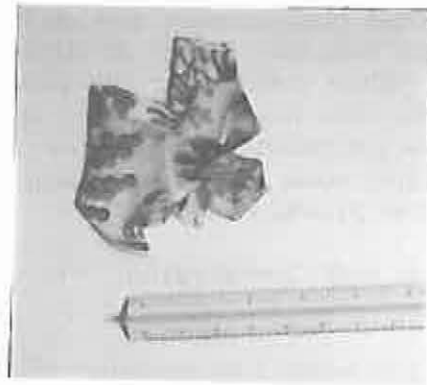
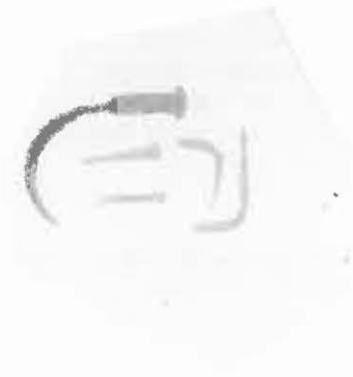
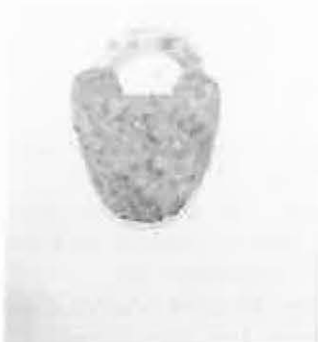
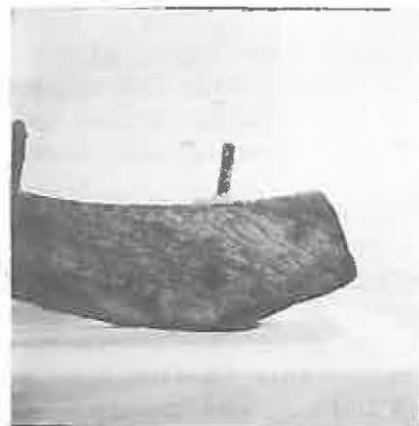
Figure 5. Artefacts from the Griffon Cove Excavation  
A. Blue transferware  
B. Iron nails  
C. Iron padlock  
D. Ceramic sherd  
E. Maker's mark  
F. Surface checking on gripe

In 1979 a short follow-up investigation was undertaken in Griffon Cove. A number of artefacts were recovered from the outer portion of the cove. These included a padlock similar to the one in the Vail collection (Fig. 5c), more ceramic sherds, one with a maker's mark 'Barker and Son' (Fig. 5d & e) and a number of clay pipe stems.

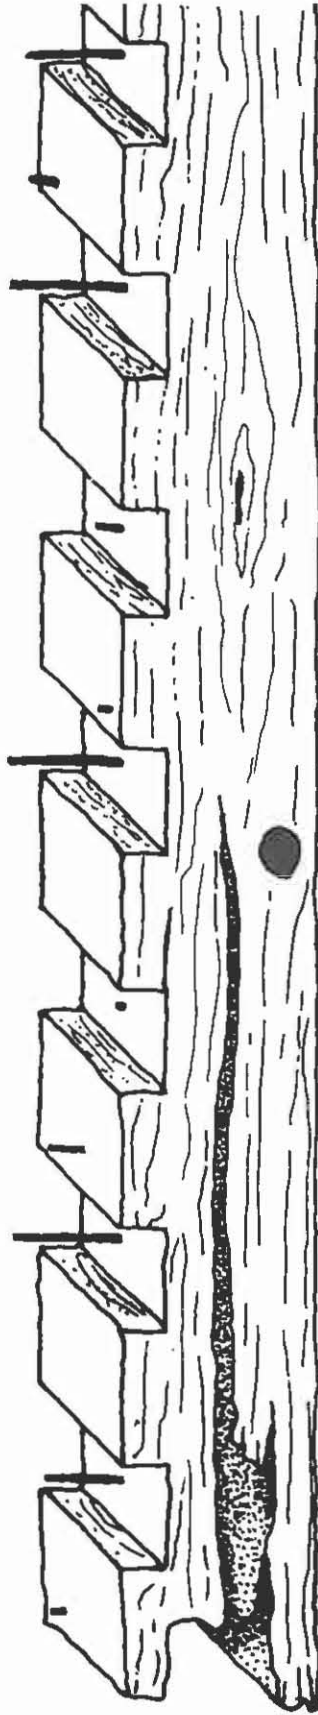
Figure 6. Bolting pattern of the Griffon Cove Wreck

The top of the keel is notched to receive 30 floor timbers. The notches vary from 1.3 to 2.5 in (33 - 64 mm) in depth and 5.2 to 5.5 in (132 - 140 mm) in length. An iron bolt or a hole for a bolt no longer extant are still in place and occur in the centre of each of these notches. There is also a bolt or a bolt hole on the top of the keel surface between each consecutive pair of notches (Figs. 6 & 7e).

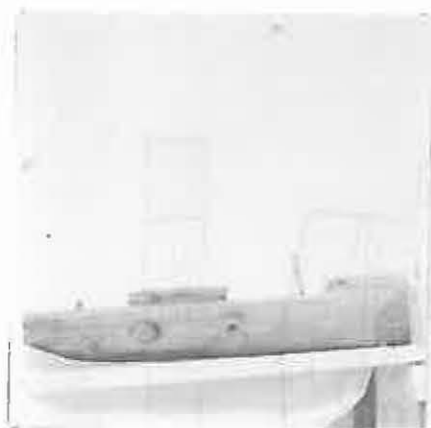
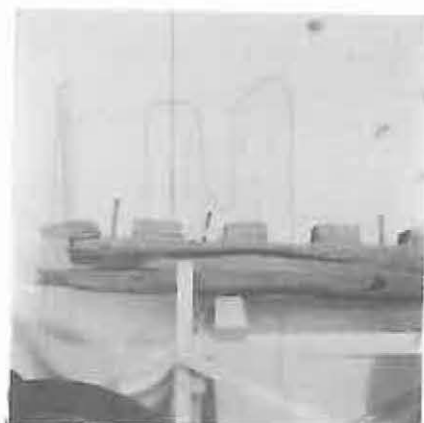
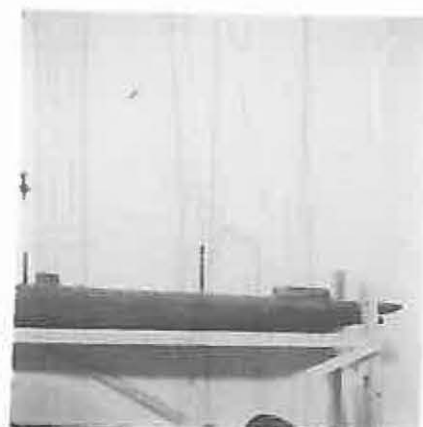
Figure 7. Construction features of the Griffon Cove Keel

A. Stem scarph, port side	D. Hole amidships, forward end of after keel section
B. Stem scarph, starboard side	E. Notches in keel
C. After end of forward keel section	F. Stern knee scarph

There are three holes, approximately 2.5 in (64 mm) in diameter, in the starboard side of the keel. Two are located under the stem scarph (Fig. 7a), and the other is amidships (Fig. 7d). The after hole under the stem scarph is cut only half way through the keel and intersects a vertical hole in the scarph (Fig. 7b). The other two holes are cut completely through the keel.

The same type of scarph joint was used in the stem and stern of this vessel (Figs. 7a & f).

There are rectangular indentations at various points along the side of the keel (Figs. 7a & f). Two occur on either side of the forward keel section. Both are 2.5 in (64 mm) wide and 0.5 in (13 mm) deep. The fastening holes within them are approximately 0.5 in (13 mm) and 0.25 in (6 mm) square. On the after keel section three depressions are visible on the port side and five on the starboard side. All except the aftermost depression on either side are approximately the same size as those on the forward keel section. The two aftermost depressions, one occurring aft of the stern knee scarph, on either side of the keel are the largest and have been partially lost due to abrasion (Fig. 7f). Both of these depressions are 10.5 in (267 mm) long, 4.0 in (102 mm) high, and 0.5 in (13 mm) deep. Three nail holes are visible in the starboard depression, while five nail holes can be seen in the port side depression.

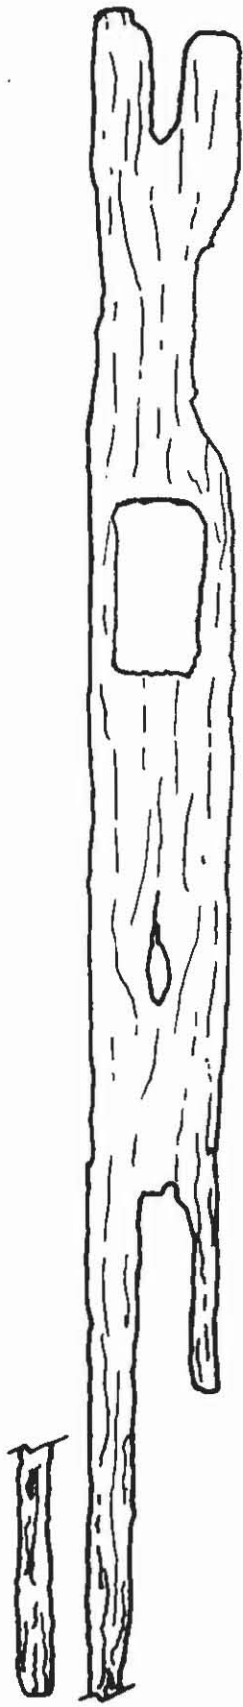
OCV-102

Figure 8. Keelson fragments from the Griffon Cove Vessel

Two segments of the keelson were found and analysed. One piece, OCV-77-01-102, is 8ft 5 in (2.565 m) long, is moulded 7.5 in (191 mm) and is sided 3.0 in (76 mm) (Fig. 8). This piece has a 4.5 in (114 mm) by 9.0 in (229 mm) rectangular hole cut in it. There is evidence of three bolt holes along its length. The other piece, OCV-77-01-103, is 6 ft 10 in (2.083 m) long, has a maximum width of 8.5 in (216 mm) and a thickness of 3.0 in (76 mm). It also shows evidence of three bolts along its length.

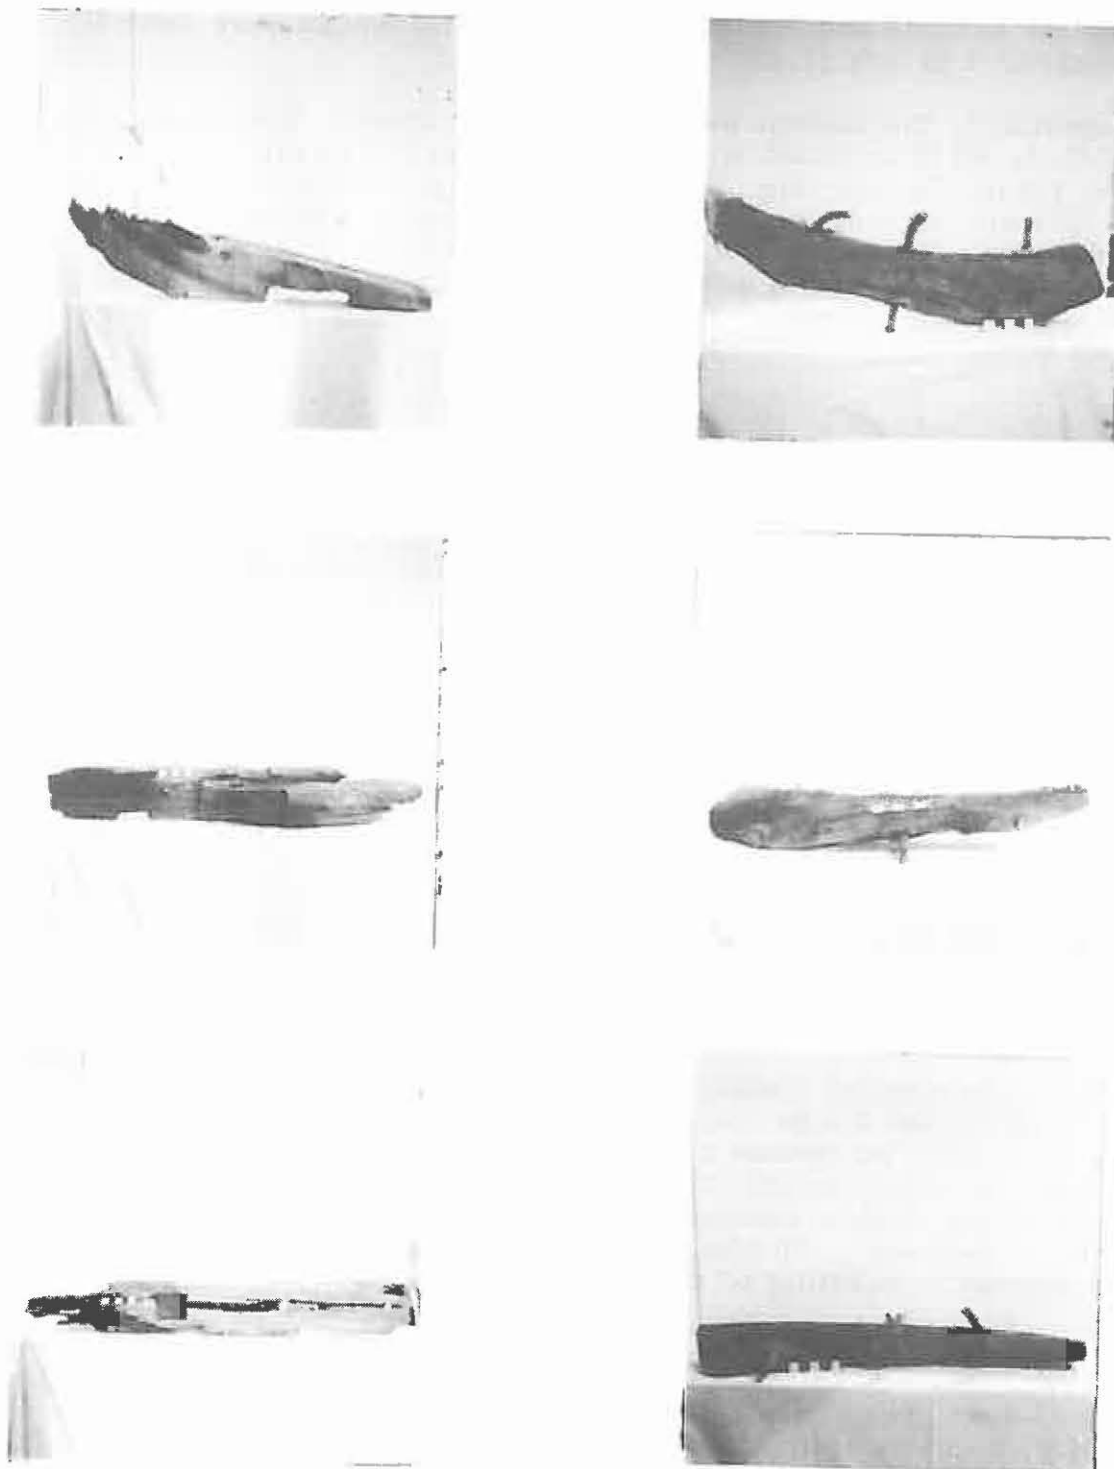
Figure 9. Timbers from stem construction of the Griffon Cove Vessel  
 A. Stempost  
 B. Bottom of stempost  
 C. Top of stempost  
 D. Gripe  
 E. Bottom of gripe  
 F. Top of gripe

The stempost was scarphed onto the forward end of the keel. It was fastened to the top of the keel by four iron bolts: one forelocked bolt\* 1.0 in (25 mm) in diameter and three drift bolts 0.5 in (13 mm) in diameter. It curves upward from the end of the keel to a point where erosion or breakage has destroyed all remaining evidence of its upper shape (Fig. 9a).

There are three bolt holes in the leading face of the stempost (Fig. 9b). The upper bolt hole is in the eroded area of the timber but is evident due to compressed grain which did not deteriorate as rapidly as the wood around it and by a rust stain in the bolt hole.

The top of the stempost contains a mortice 5 in (127 mm) long, 4 in (102 mm) wide, and 3.5 in (89 mm) deep (Fig. 9c). In the base of the mortice is a round impression and a shallow v-notch. There is a crack which runs the entire length of the stem piece and the deteriorated condition of the wood is causing this crack to threaten the structural integrity of the piece. Careful handling was necessary to prevent further damage or splitting of this piece into two parts.

The gripe (Figs. 9d, e & f) was recovered in 1978. This timber is 35 in (889 mm) long on the inside radius and 41 in (1.041 m) long on the outside radius. The gripe is tapered both from head to heel and from the inside, which is against the stem knee, to the outside or leading edge. At the heel this piece is trapazoidal, moulded 4.6 in (117 mm) inside and 3.7 in (94 mm) outside, and sided 5.5 in (140 mm). At the head it is almost rectangular, moulded 2 in (51 mm) inside and 2.1 in (53 mm) outside, and sided 4.5 in (114 mm).

Three iron bolts are still firmly in place in the gripe. They are all 0.875 in (22 mm) in diameter and vary in length between 10 and 12 in (254 to 305 mm). The middle bolt has been exposed due to a large piece of the gripe being split away (Fig. 9e). The heads of the other two bolts are flush with the wood surface. The bolts nearest the head have been bent, both in the same direction as if they were twisted away from the stem by force.

The radius of the gripe on the inside face, where it butted against the stem, is a smooth curve. The outside radius has two distinct flat spots. One flat occurs at the keel where this piece butted. The gripe extends straight for 8 in (203 mm) before it starts to curve upward. The first bolt was driven at the point where the flat stops and its curve begins. This same pattern occurs at the head of the gripe. The uppermost bolt is driven where the curve stops and the gripe extends 9 in (229 mm) straight up to the end of the piece (Fig. 9d).

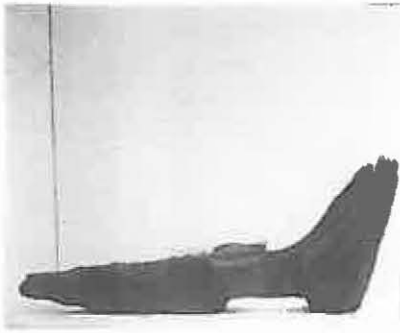
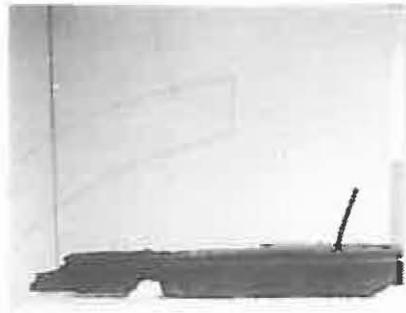
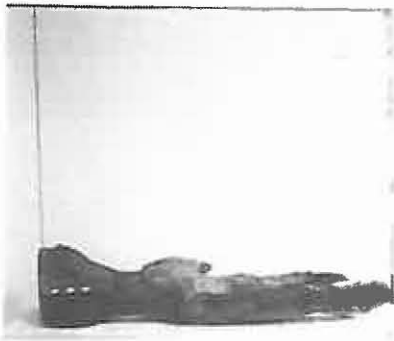
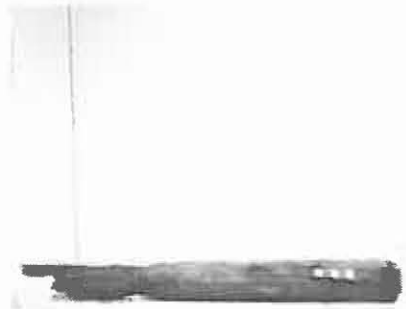
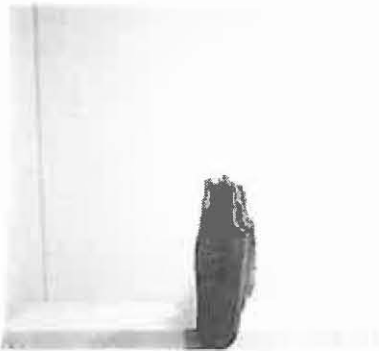
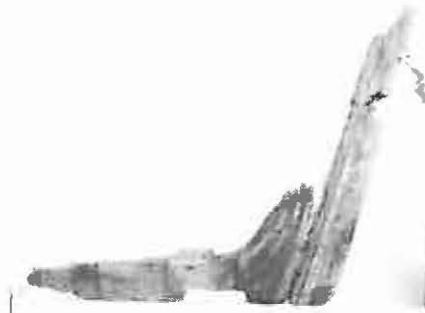
Figure 10. Timbers from stern construction of the Griffon Cove Vessel  
A. Stern knee  
B. Bottom of stern knee  
C. Bolt hole in stern knee  
D. Sternpost  
E. Forward face of sternpost  
F. Stern knee and sternpost

The stern assembly consisted of a stern knee\* scarphed to the keel and a sternpost bolted to the knee (Fig. 10f). There is no evidence that any other timbers were used in this portion of the vessel. The stern knee is 4 ft 2 in (1.270 m) long, and is moulded 8 in (203 mm). There are four notches visible on each side of the knee. Nail holes indicate where the half frames were attached. There is a row of nail holes that run along the side of the knee near the bottom. Two nail holes are evident, higher on the timber where the knee starts to curve upwards.

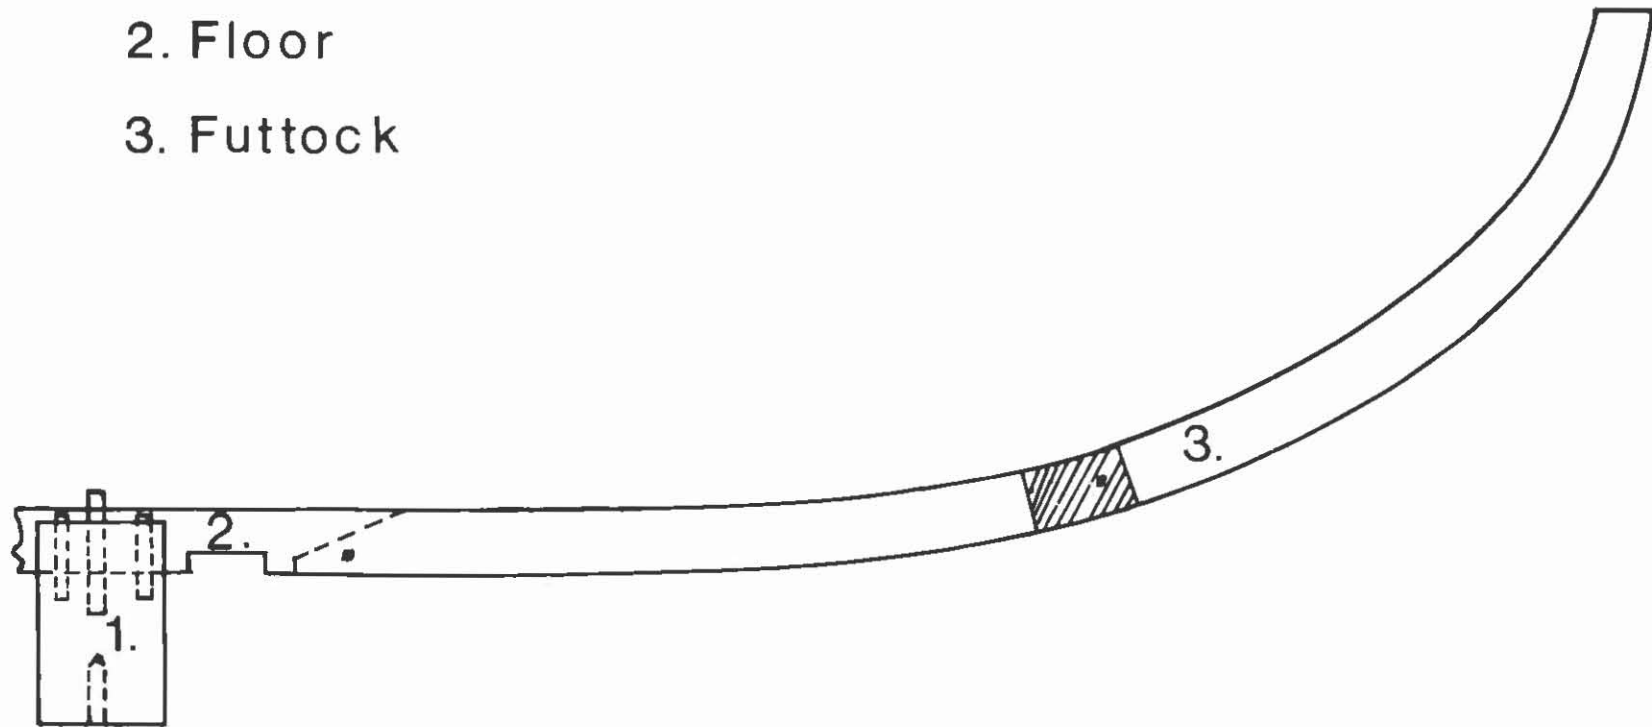
- 1. Keel
- 2. Floor
- 3. Futtock

Figure 11. Typical frame section of the Griffon Cove Vessel

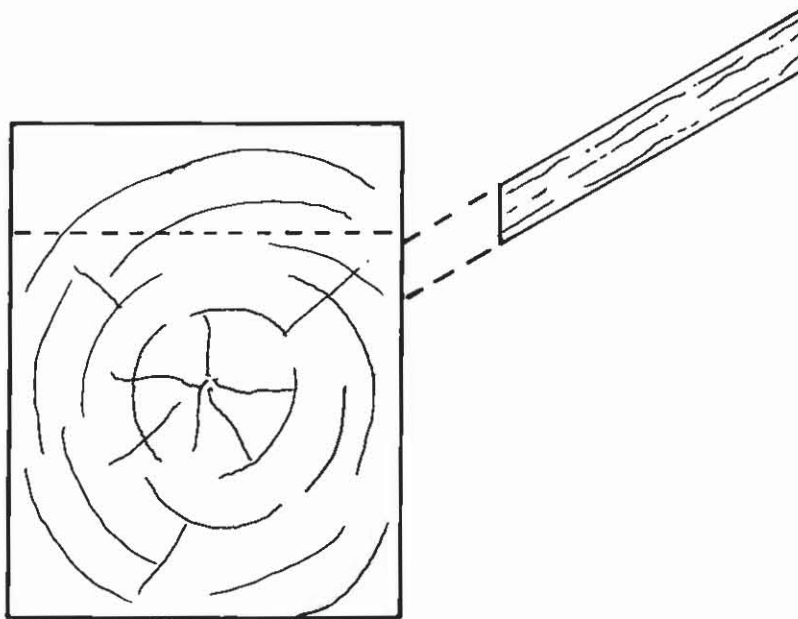
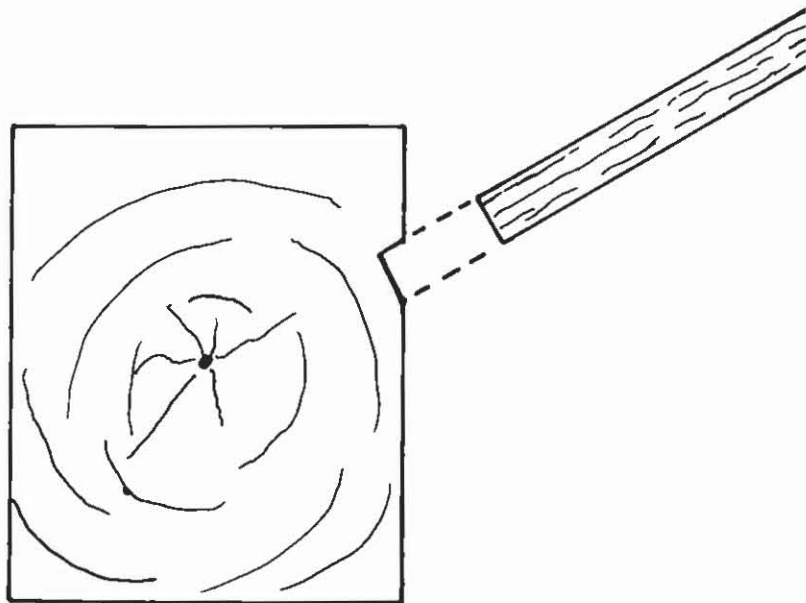
Griffon Cove Keel And Garboard

Rabbeted Keel And Garboard

Figure 13. Keel-garboard construction of the Griffon Cove Vessel and construction of a rabbeted keel

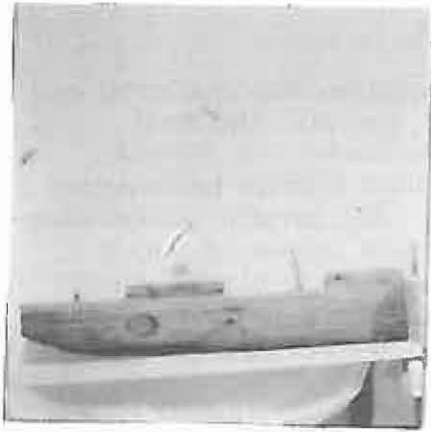
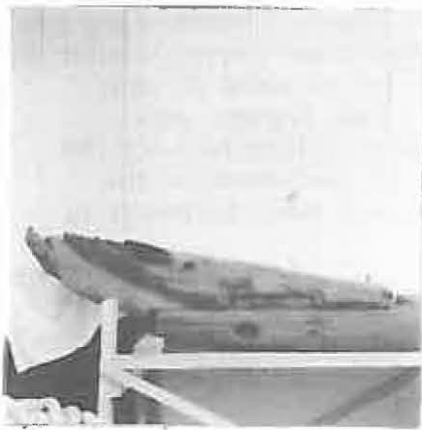
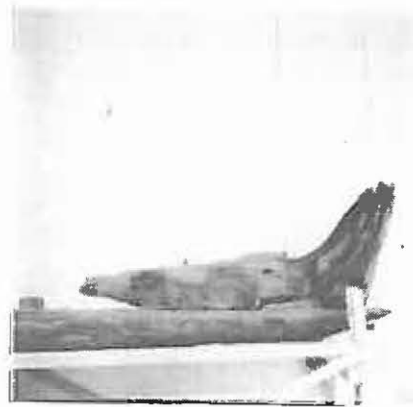
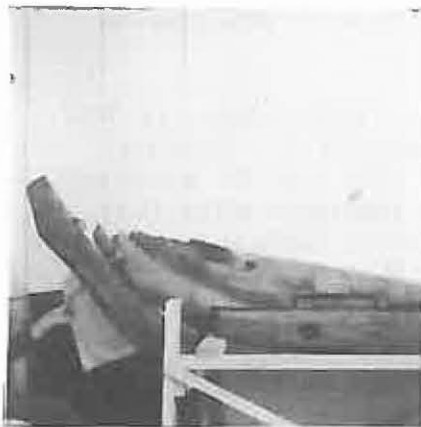
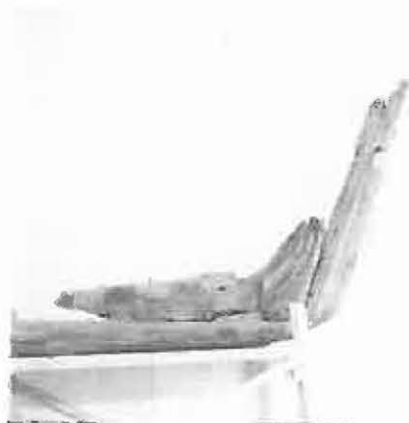
Figure 14. Construction of the Griffon Cove Vessel's stem and stern  
 A. Stem scarp on keel  
 B. Stempost on keel  
 C. Complete stem construction  
 D. Stern scarp on keel  
 E. Stern knee on keel  
 F. Complete stern construction

The stempost has probably lost some of its shape due to erosion. This may be seen more clearly when the gripe is held in position (Fig. 14c). The bottom of the gripe should be even with the bottom of the keel shoe. With the gripe in this position, there is a significant gap between it and the stempost at the forward end of the keel.

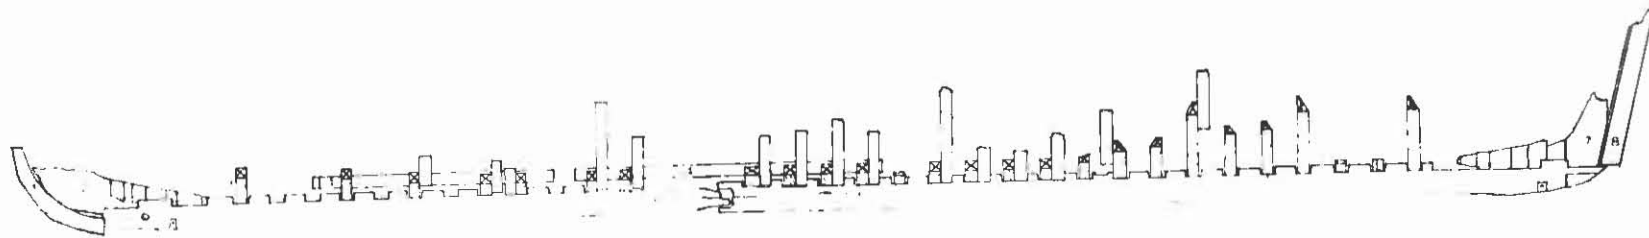
1 Gripe 2 Stem Knee 3 Floor 4 Keelson 5 Fullock 6 Keel 7 Stern Knee 8 Stern Post

Figure 16. Plan and profile on the Griffon Cove Timbers

The timbers found on Russel Island have been reconstructed to the greatest extent for which there was physical evidence (Fig. 16). With the aid of a model (Fig. 17), the individual timbers were placed in positions which would yield a fair hull shape. Working from the frame shapes recorded in Canada and modeled at Texas A&M University, a set of hull lines were developed (Figs. 18 & 19). The use of these ship lines played a major role in drawing conclusions from the remaining timbers of the Griffon Cove wreck.

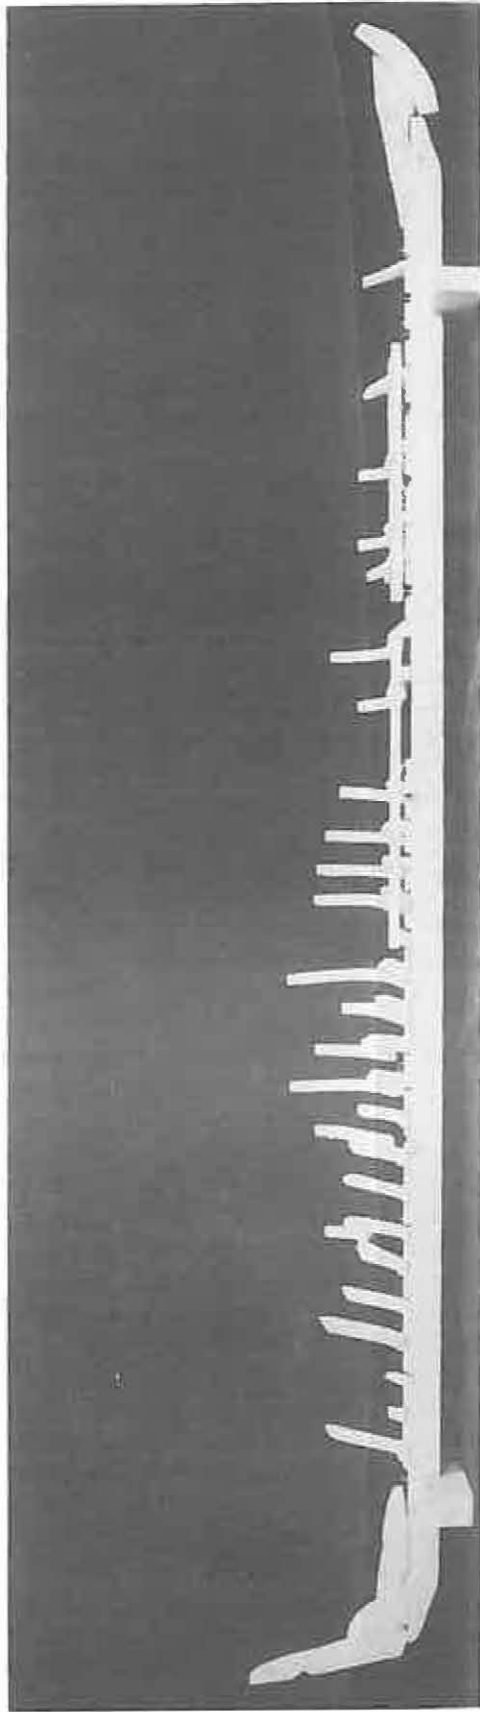
Figure 17. Model of the Griffon Cove Timbers

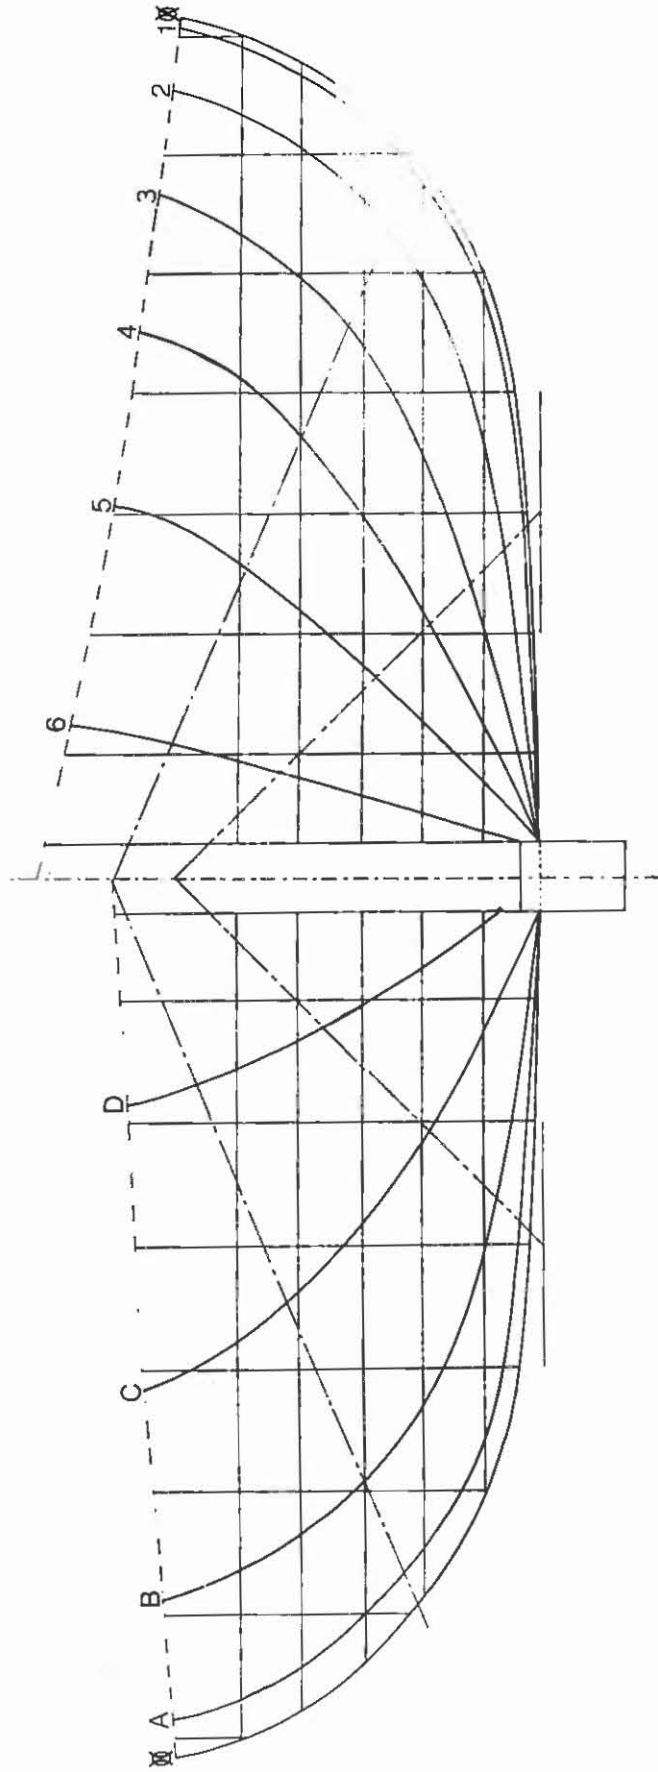
Figure 18. Body plan of the Griffon Cove Vessel's hull lines

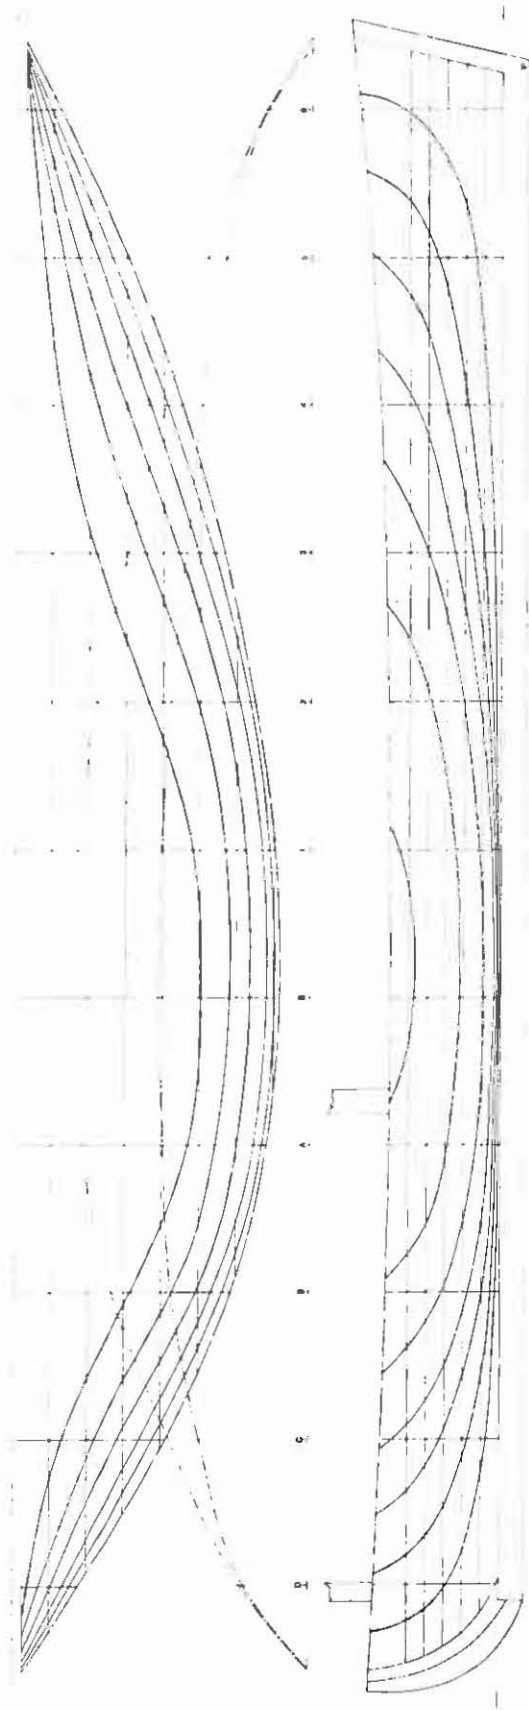
Figure 19. Sheer and half breadth plans of the Griffon Cove Vessel's hull lines

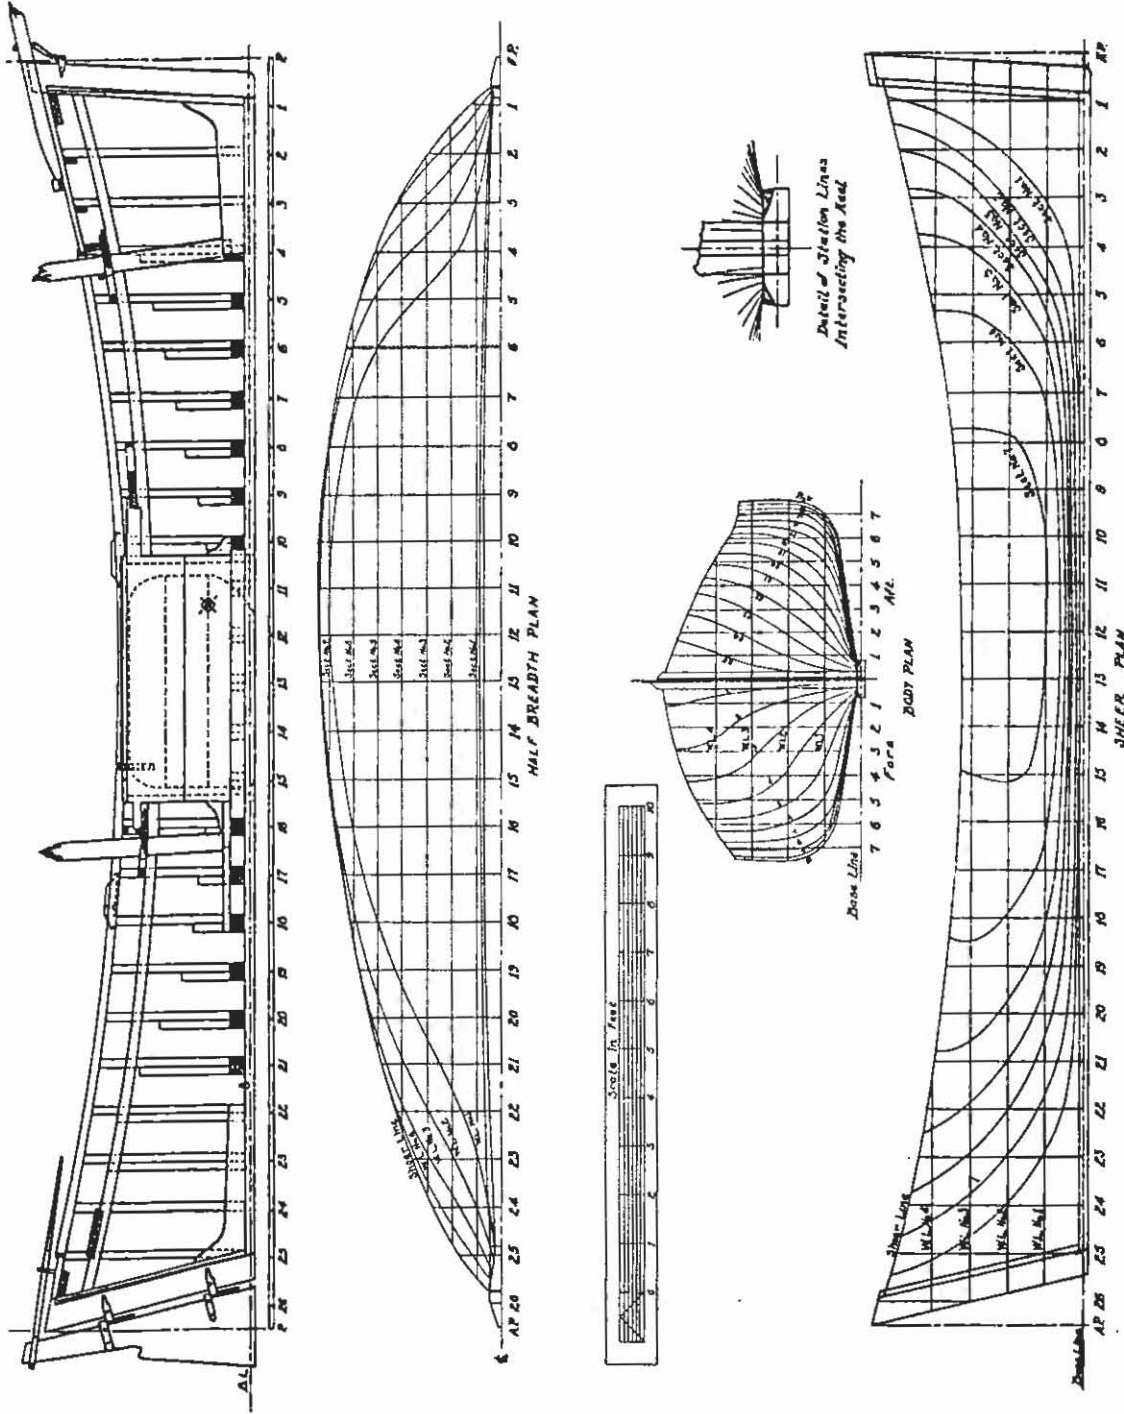
MACKINAW BOAT "WABCSJ"  
 Built by Shoney at St. Ignace, Michigan about 1843  
 Owned by Joseph Osprey of Masset, Alaska

Figure 20. Hull Lines of a Mackinaw Boat

The hull lines developed from the timbers of the Griffon Cove wreck suggest a variation of a Mackinaw boat, consistent with the type of vessels used on the Great Lakes during the mid-1800's (Fig. 20) (Nevill, 1955: 8). The journal of Captain Jesse Wells Church (10), for example, offers a comprehensive look at a local naval architect and the operation of a small shipyard. Other Canadian and United States shipwrights would have been using similar designs and techniques.

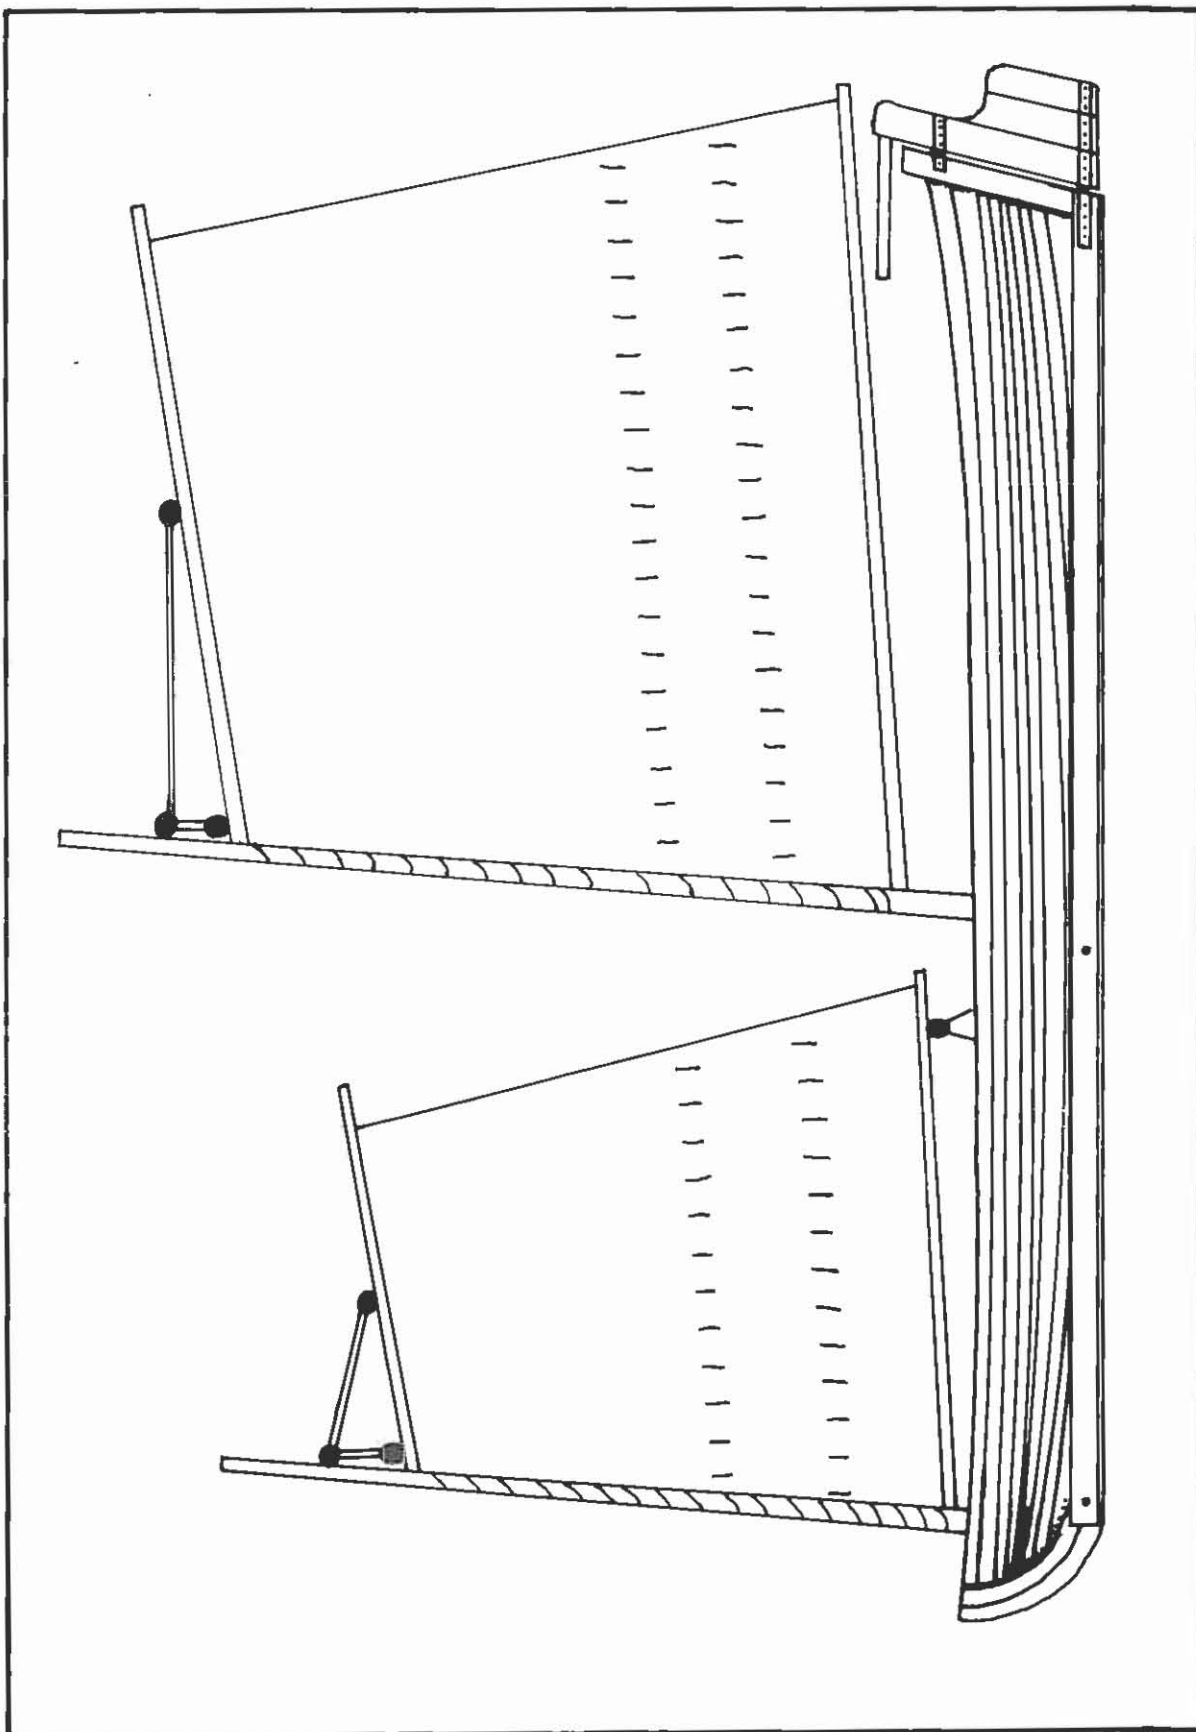
Figure 21. Griffon Cove Vessel as Reconstructed

A graphic reconstruction of the Griffon Cove vessel was drawn, complete with sails and rigging, based on contemporary plans and publications (Fig. 21). The hull remains found on Russel Island gave no information about the rig which may have been used, except for the placement of the two masts. The rig shown in the drawing is compatible with the reconstructed hull lines and will allow one to better visualize the Griffon Cove vessel while it was afloat.
